Evaluation of the Failure and Reinforcement of the Foundation in a 20 Storey Residential Building

Abstract In this study, we present the results of the forensic analysis and solution proposed for the foundation of a 20-storey building located in the center of the city of Oviedo (Spain), built between 1957 and 1962, and renovated in 2002. During a probe carried out in order to evaluate the original foundation, it was observed that the resistance of the ground was slightly less than that considered for the calculation, and therefore the foundation of the building had to be reinforced. In this paper, we present a detailed description of the problem; determine the source of the failure, present the solution adopted and the constructive process followed. After evaluating different solutions, we opted to construct caissons. In this manner, the foundation of the building was moved to a level with a more resistant layer of ground. The focus of this study is to present as a main cause of the failure the infiltration of sludge waters coming from a manifold located in the surrounding area of the building, which altered the subsoil and caused it to lose resistance. Also relevant is the constr

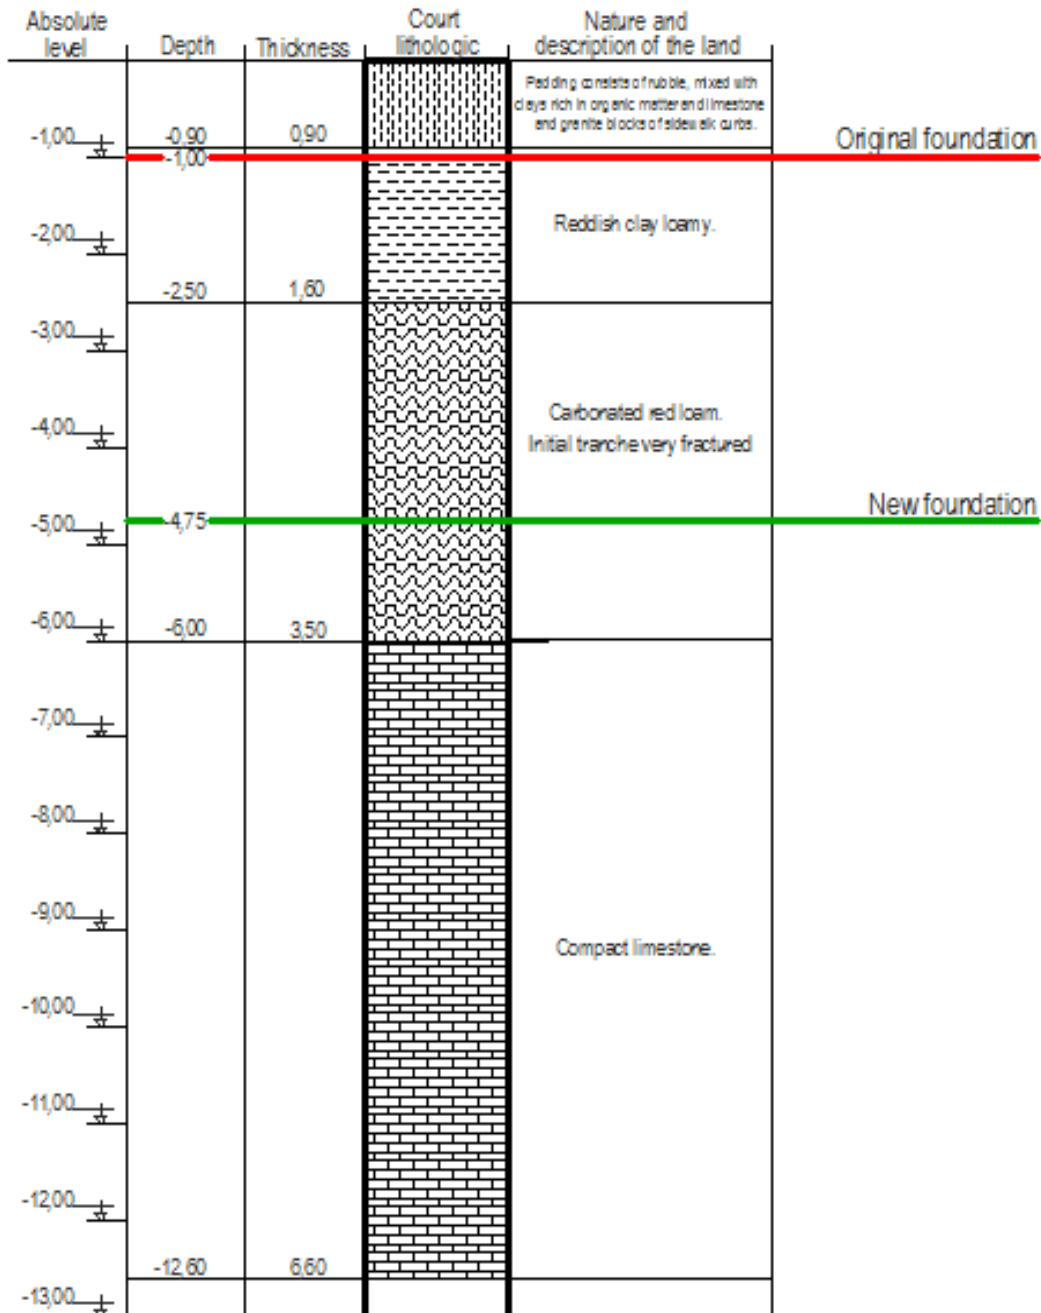
Figure 3. Section obtained on the ground by means of the probe carried out

In order to verify these extremes, another geotechnical study was carried out. To do so, probing was conducted on the sidewalk of the main facade of the building. The results obtained determined that the layer of ground where the foundation was laid was built with reddish marly clays, caused due to the alteration of the loams, which was likely due to the sludge waters, with an allowable stress of 0.20 to 0.25 MPa—slightly less than that considered for the calculation. Figure 3 represents a section of the ground obtained based on the data from the probe carried out. The analysis carried out on the sample of water collected in the

Having examined the results obtained, the interior foundation of the building was inadequate. The perimeter footing did not present any type of problem. From the same study, it appears that a layer of ground with an allowable stress greater than 0.35 MPa was located at an average depth of 2 m with respect to the depth of the original foundation.

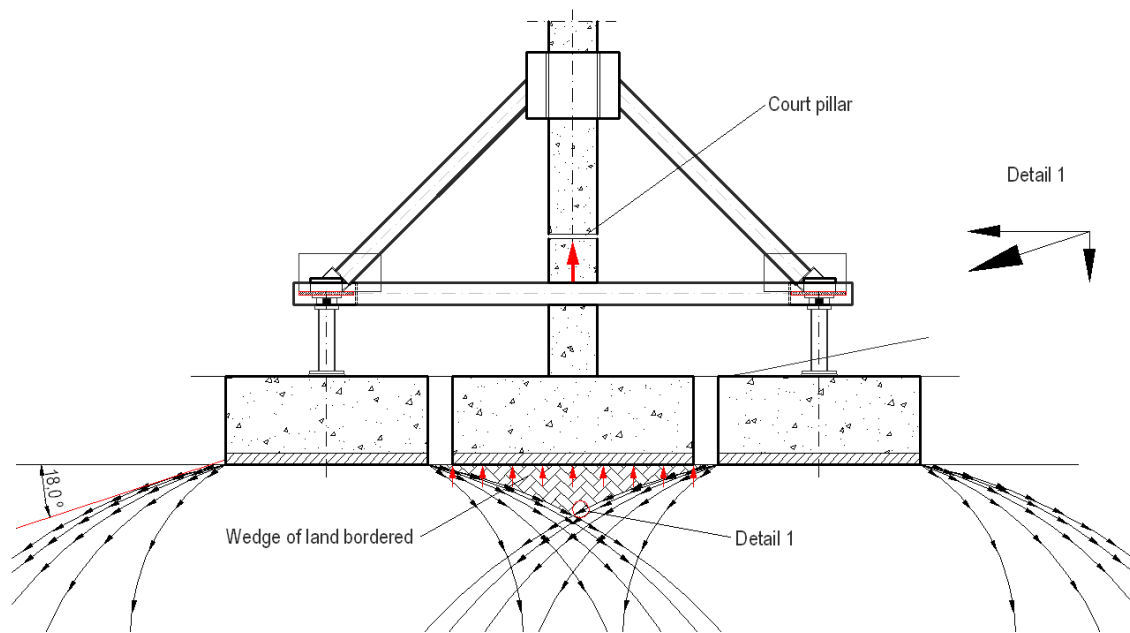
Figure 8. Interaction of the pressure bulbs of the auxiliary footing

It is worth mentioning that 12 hours after sectioning the first pillar, we observed its two parts joined together again. In the first instance, such circumstance seemed to correspond to a lowering of the cut pillar caused by a possible deficiency in the joint with epoxy resin of the pillar to the auxiliary metallic structure.

However, after carrying out a new leveling, verifying the marks made on the pillar prior to the cut, it was observed that,

in reality, the lower part of the sectioned pillar, along with the original footing, had suffered an upward shift due to the interaction of the pressure bulbs of the auxiliary footing on the confined ground on which the original footing stands [8], as can be observed in figure 8.

Once the pillar is cut, the ground confined between the pressure bulbs corresponding to the auxiliary footing used for unloading the pillars undergoes an increased compression stress that tends to lift up the original block and the section of lower pillar that was previously cut.

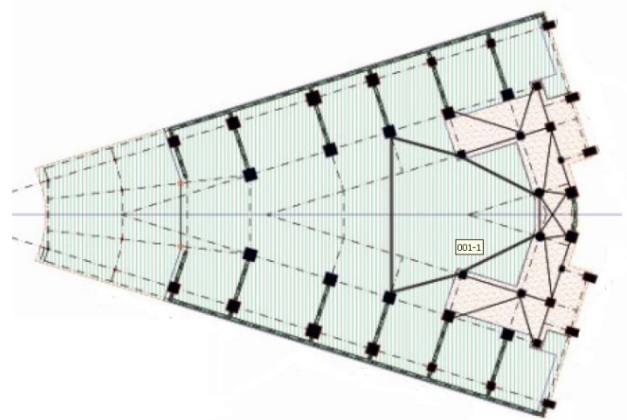
Figure 13. Foundation zone reinforced using caissons

Some of the columns bore a maximum load of 120 t. While the auxiliary structure was able to support 125 t and the caisson 140 t. Due to this situation some areas in the structures were forced (Figure 13).
