Title: Morphology and causes of landslides in Portalet area (Spanish Pyrenees): probabilistic analysis by means of numerical modelling

Article Type: Original Research Paper

Keywords: Landslide, geotechnical monitoring, numerical modelling, creep, cracks

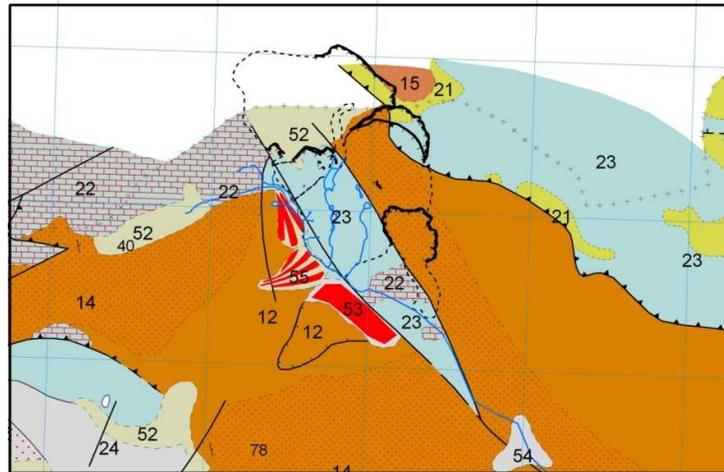
Figure2.- Portalet landslide area geology

The study area encompasses the magmatic and Paleozoic complex of the axial Pyrenees, affected by the Hercinian folding phase. A geological map (Rios-Aragüés et al. 1987) [14] is shown in Figure 2. The centre of the valley is characterised by an outcrop of Devonian slate (12 and 14 in Figure 2), whereas in the northern part, this formation is overthrust by the Carboniferous Limestone formation (21 in Figure 2). There is also an outcrop of conglomerate and carboniferous greywacke (23 in Figure 2). These materials are usually covered by Quaternary sediments: alluvial or alluvial fan deposits in the valley and colluvial deposits on the slopes that present a significant thickness favoured by the weathering process of highly fissile slate formations with a relatively low rock mass strength. The toe of the scarps is usually covered by talus or rockfall deposits. The study area shows medium-low seismicity (Mulas et al. 2003) [15] and is controlled by two tectonic lineaments, one following the NW-SE direction parallel to the valley and the other following the SW-NE direction.

**Figure 2.- Portalet landslide area geology**

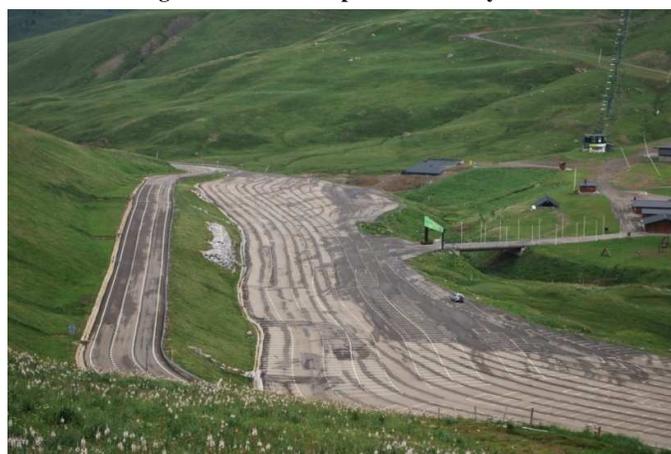
Figure 4.- Creep phenomena in the parking-lot area.

Both factors have caused many creep areas, cracks and flooded areas. (Figure 4 and Figure 5).

**Figure 4.- Creep phenomena in the parking-lot area.**

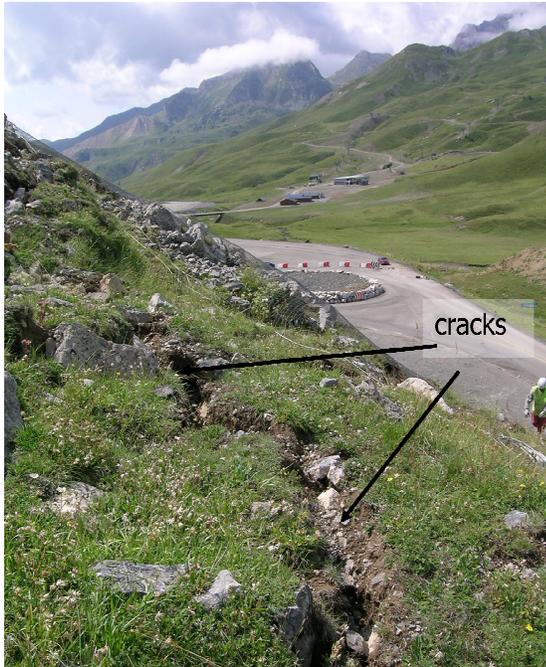
Figure 5.- Cracks details in the crown zone in one displacements

**Figure 5.- Cracks details in the crown zone in one displacements**

The excavation at the foot of the slope, carried out to build a parking lot area in the summer of 2004, reactivated existing slide surfaces and generating new fissures and cracks. The most important set of cracks is observed halfway up the slope and others are seen on the cut slope benches of the parking lot construction. The occurrence of this landslide prevented the completion of the digging and part of the removed material was replaced immediately at the landslide's foot in order to arrest the process. As soon as this emergency measure was over, constructive solutions were performed to stabilise the hillside without interfering with the construction of the parking lot. These solutions involved reprofiling the landslide toe and adding weight and building benches to stabilise the slope. Small retaining walls and drainage were also built where the slip surface outcrops.

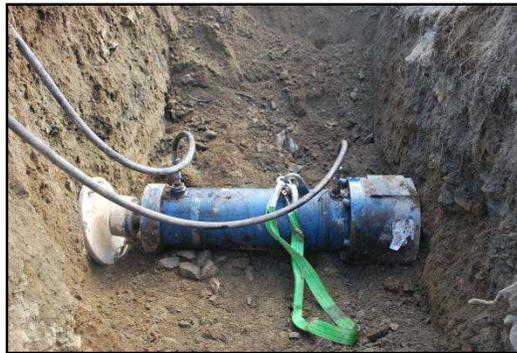
Figure 6- Hydraulic cylinder placed in a trench

Previously, to execute the test, it was necessary to make a trench on the terrain and to place the cylinder inside; such the ends of the cylinder are placed perpendicularly to the walls of the

trench, as can be seen in Figure 6.

**Figure6- Hydraulic cylinder placed in a trench**

Once the cylinder is placed into the trench, pressure is applied and increased gradually. This pressure is transmitted to the terrain, perpendicularly through a cylindrical pin owing to the ball joint. In most tests, the pressure increases until terrain failure occurs. This type of test allows the stress-strain curve of the terrain to be determined because the failure pressure in each analysed material can be calculated and a residual pressure estimated. It can also be estimated the penetration experimented by the hydraulic cylinder when it is in charge, until the failure terrain is produced.

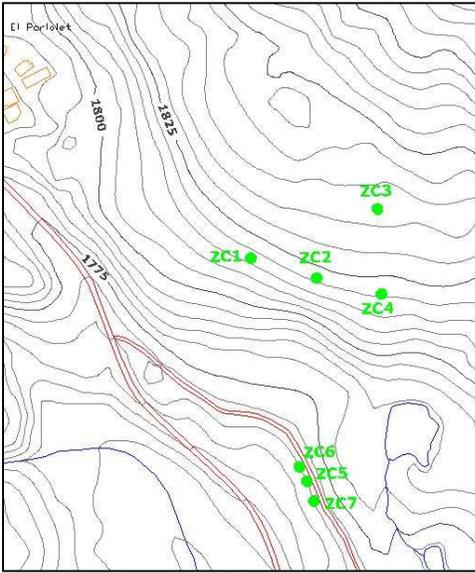
Figure 7.- Location of the trench for the penetration tests

Thirteen tests were made along seven trenches. Figure 7 shows their location.

**Figure7.- Location of the trench for the penetration tests**

The first four trenches were excavated in the slope with the objective of analysing the properties of the materials involved in creep surface movements. The remaining trenches were made in one of the slopes of the parkinglot, where the base of the largest depth of slip surface could be located.

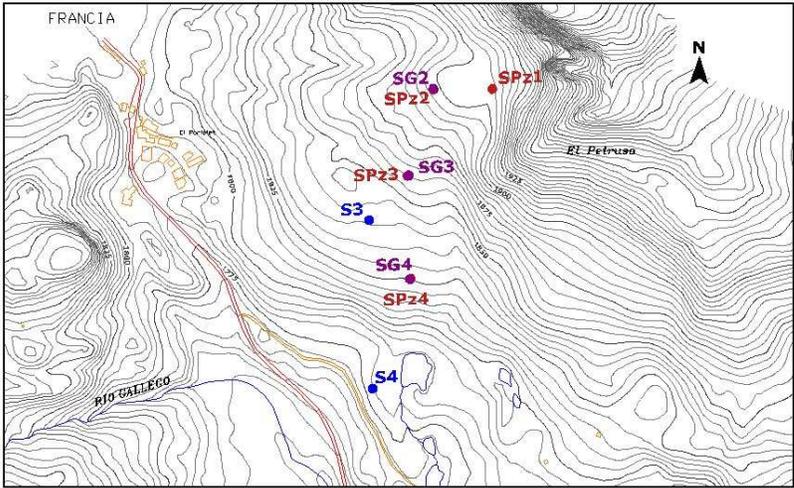
Figure 8.- Location of the boreholes

Figure 8 shows the location of the boreholes and Table 2 shows their characteristics.

**Figure8.- Location of the boreholes**

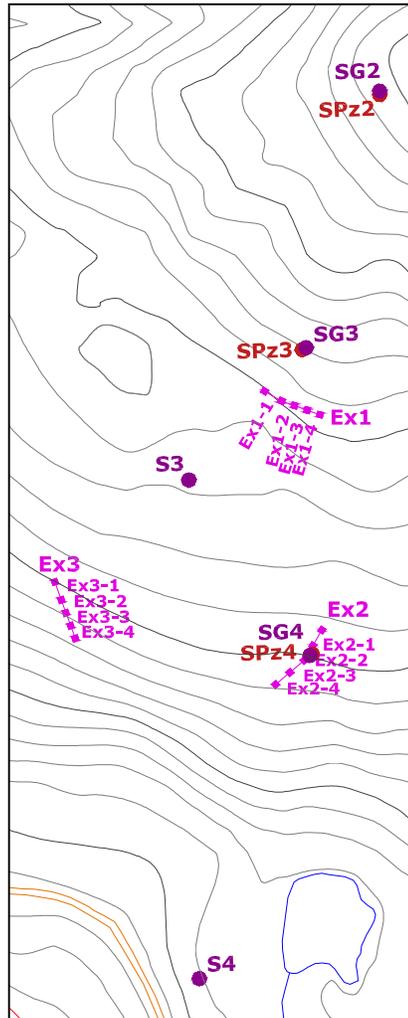
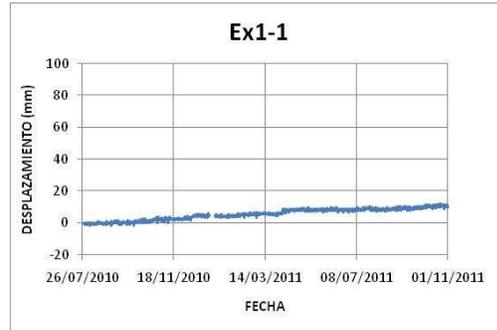
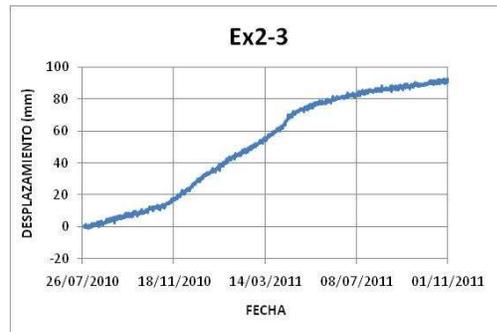
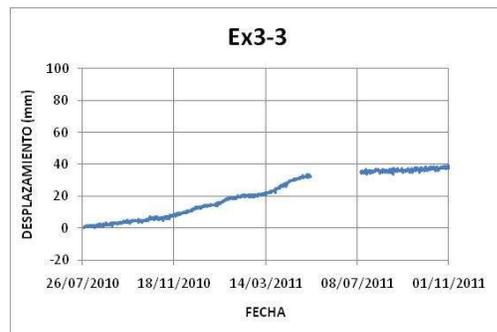
Figure 9.- Instrumented areas and graphics of the equipment that registered the highest variation in each area.

These extensometers were installed in four sequences, with lengths of between 40 and 48 m. Figure 9 shows the location of the extensometers and the graphics of the equipment that registered the highest variation in each area.

**Figure9.- Instrumented areas and graphics of the equipment that registered the highest variation in each area.**

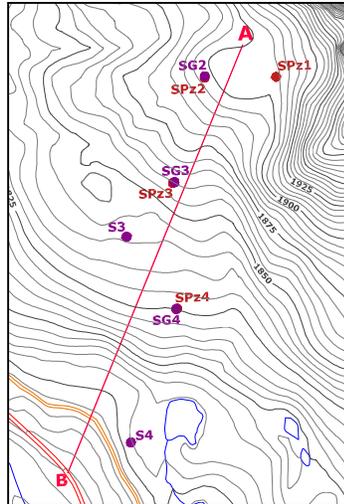
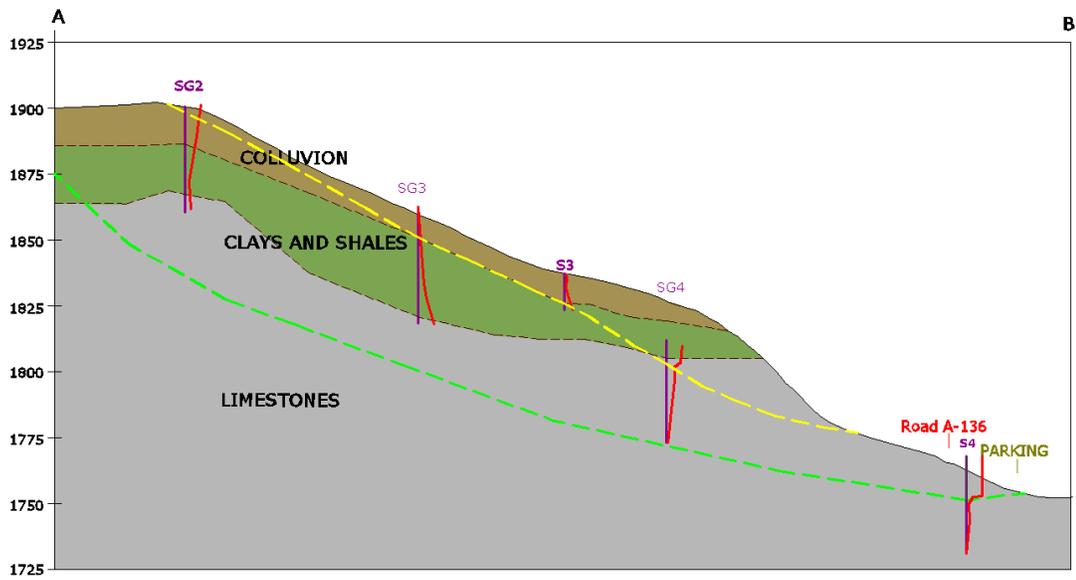
Figure 10.- Representation of the supposed morphology for the displacement.

Figure 10 shows a profile in which the boreholes made in different campaigns are represented in violet and their respective displacement curves shown in red (measured with the inclinometric probe).

As can be seen, there is a double displacement at different levels:

- A superficial movement (creep) (discontinuity yellow line, Figure 10), could explain the formation of cracks on the surface of the terrain, the movements registered by the extensometers (especially in those installed in Ex2 and Ex3 trenches) and the failure plane 10 m below surface, obtained from the inclinometric curves of the drilled borehole in 2009 on the base of the displacement (GB4) (see Figure 11).
- A deeper movement caused by the displacement of materials, such as colluvium, shales and clays above the rocky substratum that explains the displacement of the five instrumented boreholes (green discontinuity line, Figure 10).

**Figure10.- Representation of the supposed morphology for the displacement.**

Therefore, the surface of the main failure (deeper) would start at a higher height than borehole PzB1, passing below all the boreholes and below the A-136 road and probably finishing at the same level as the parkinglot.

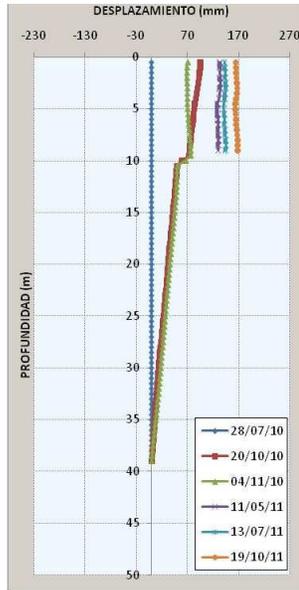
Figure 11.- Inclinometric measurements in GB4 borehole in 2005, next to base of the displacement.

**Figure11.- Inclinometric measurements in GB4 borehole in 2005, next to base of the displacement.**

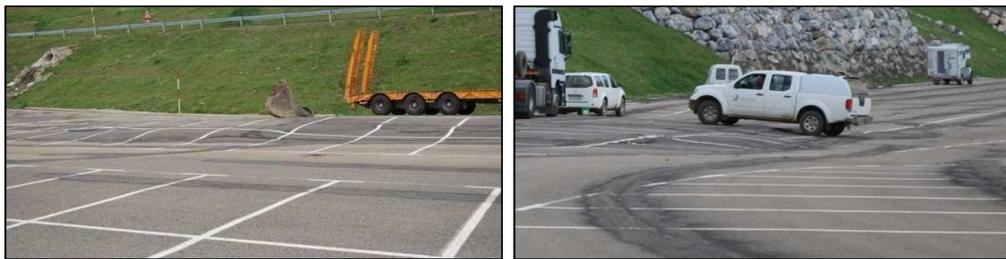
Figure 12.- Details of the parking-lot

This estimation is made by taking into account the state of the asphalt (Figure 12) and the state of the walls of the trenches excavated to make on-site tests (Figure 13), which collapsed easily.

**Figure12.- Details of the parking-lot**

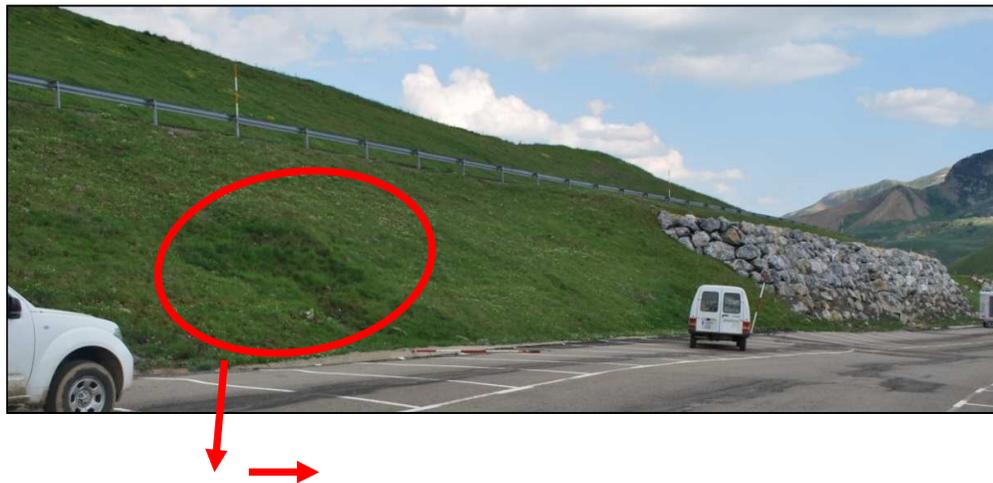
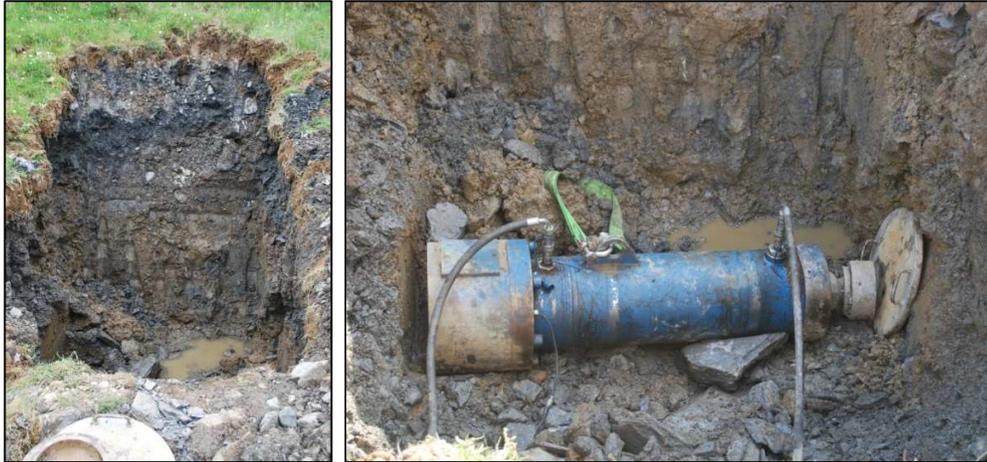
Figure 13.- State of one of the excavated trenches for the on-site tests

**Figure13.- State of one of the excavated trenches for the on-site tests.**

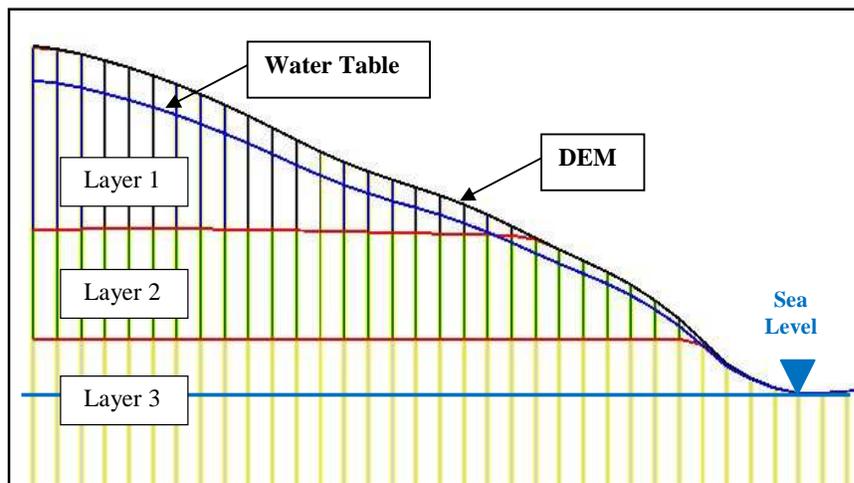
Pedological and geological characteristics are taken into account thanks to the altitude maps of the interfaces between each soil layer (Figure14). The highest limit corresponds to the topographic surface (DEM).

Figure 14.- Calculating profile generated by *ALICE*<sup>®</sup> software, showing the topographic surface, the geological model composed of three layers separated by the red lines, sea and water table levels.

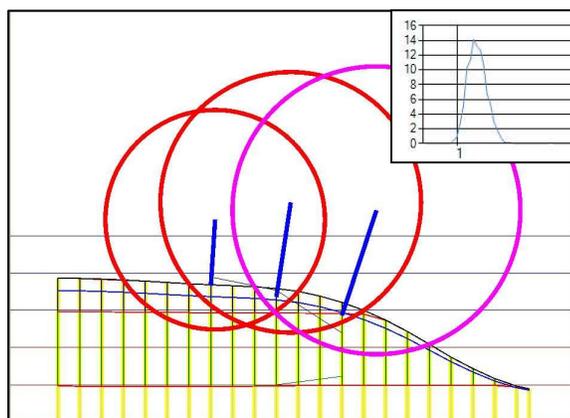
On each profile of the studied area, the software calculates the safety factors for several landslide positions (Figure15).

Figure 15.- Illustration of the way the software calculates safety factors for several landslide positions (red circles) along a topographic profile. The pink circle represents the landslide position with the highest probability of

occurrence along the profile. The graph in the top right-hand corner shows the distribution of calculated safety factors for the pink landslide.

The probability of having the safety factor below one represents the probability of the occurrence of a landslide for a given triggering scenario (i.e., landslide geometry and water table level). The dispersion of the distribution gives the uncertainty of the result.

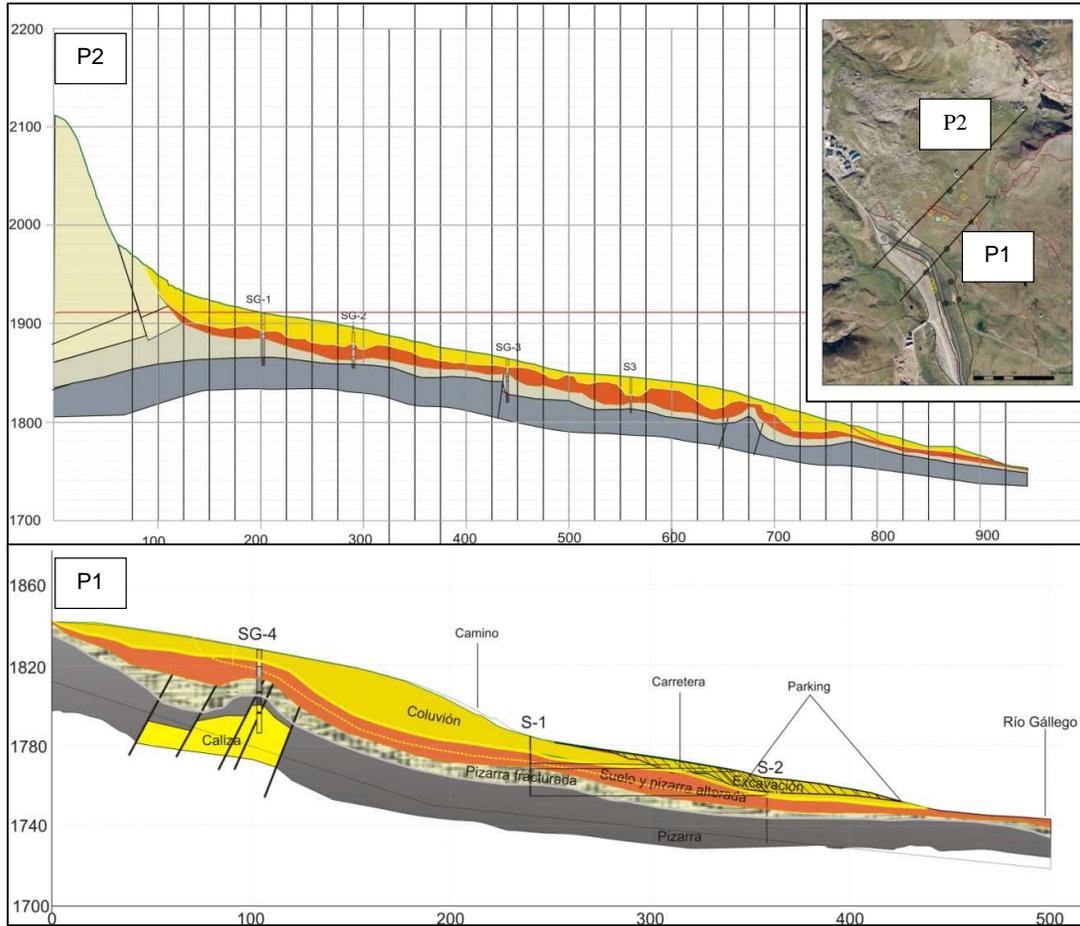
The two cross sections (see Figure16) built by the Instituto Geologico y Minero de España (IGME) with the results of the on-site tests and instrumentation, are used to determine the geometry at depth of the units comprising the geotechnical model used in the modelling.

Figure 16.- Geological cross sections interpreted from geophysical results and drilling core data obtained along two profiles P1 and P2 located on the Portalet landslide.

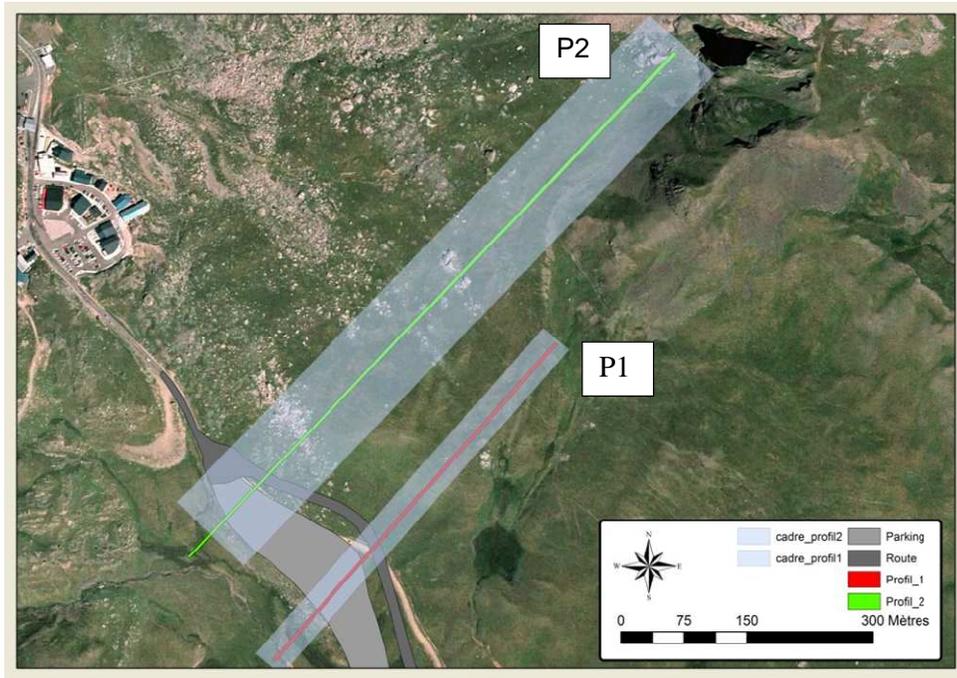
Figure 18.- Location of the strip where the depth of interfaces for geotechnical model have been extrapolated from the geological cross sections along profiles P1 and P2. The grey areas display the parking lot location (light grey) and the location of the road built in 2005 (dark grey).

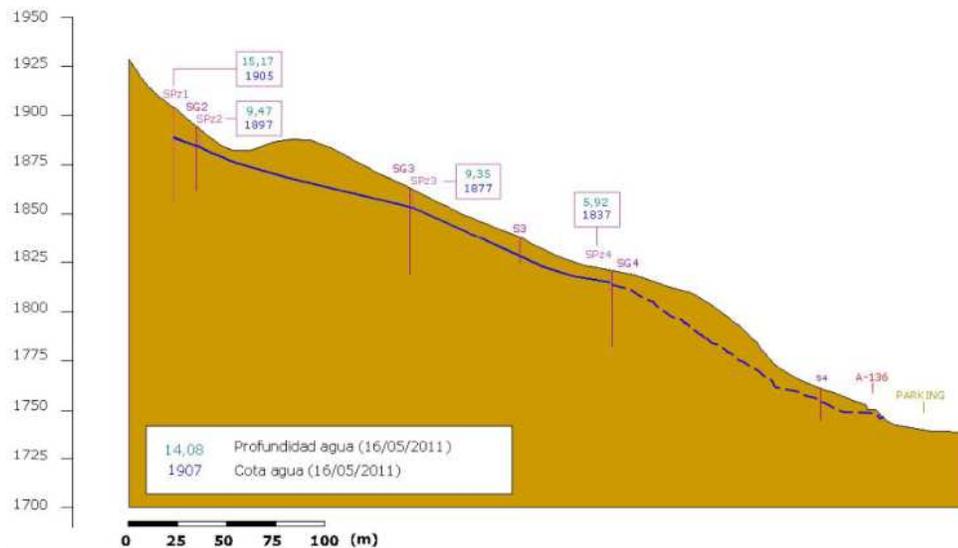
Figure 19.- Portalet landslide cross section displaying the location of piezometers and inclinometers with water table depth interpolation

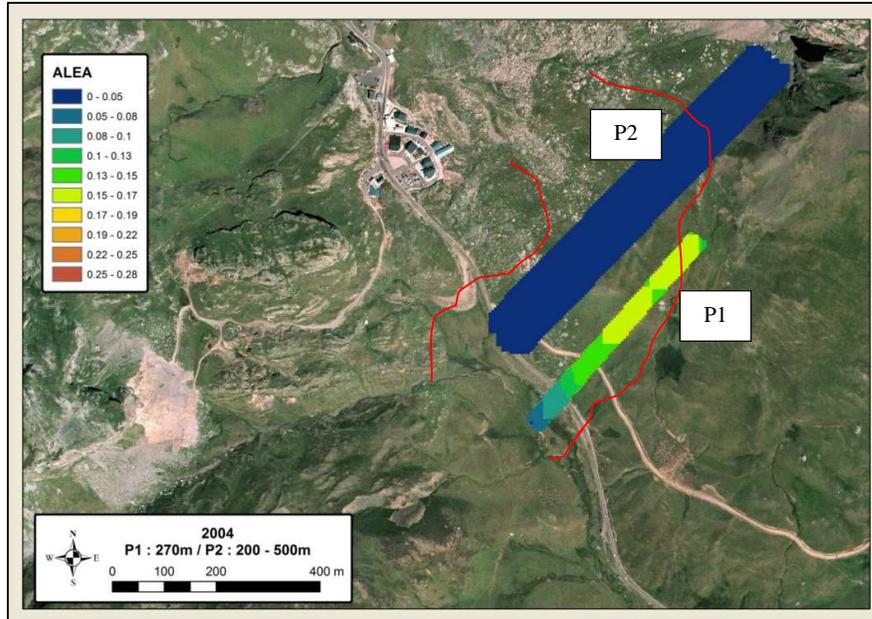
Figure 20.- Software results along both profiles P1 and P2 for the stability modelling before 2005. The red line symbolises approximately the landslide extension. Landslide length is 200 and 500 m for P2 and 270 m for P1.

A landslide of 270 m has been modelled along profile P1. The results give a probability of a landslide of between 0.15 and 0.17. The modelling displays that stability conditions were already weak prior to 2005 for this part of the landslide.

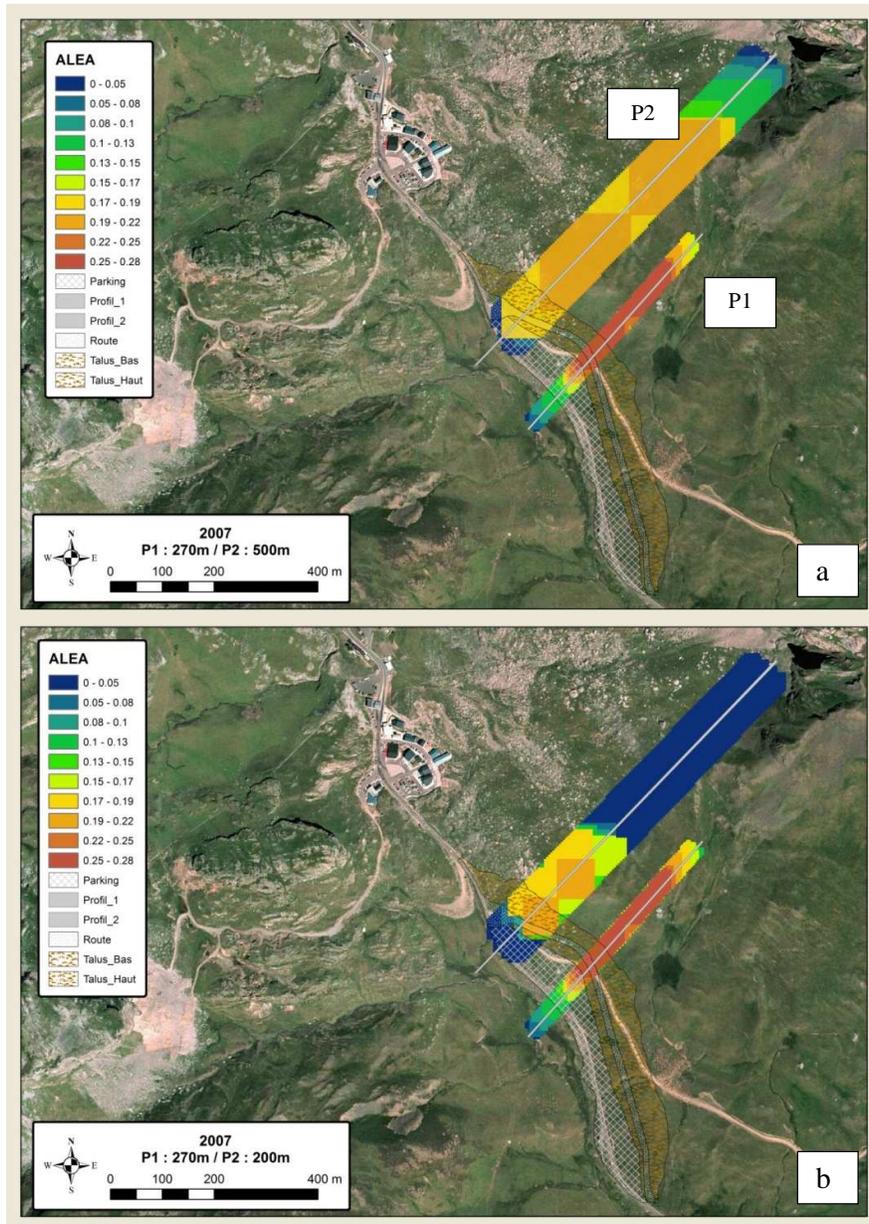
Figure 21. – Modelling results for the slope stability of the Portalet landslide after the parking lot construction (represented as a grey grid). (a) Landslide length of 500m along P2 and 270m along P1; (b) landslide length of 200m along P2 and 270 m along P1.

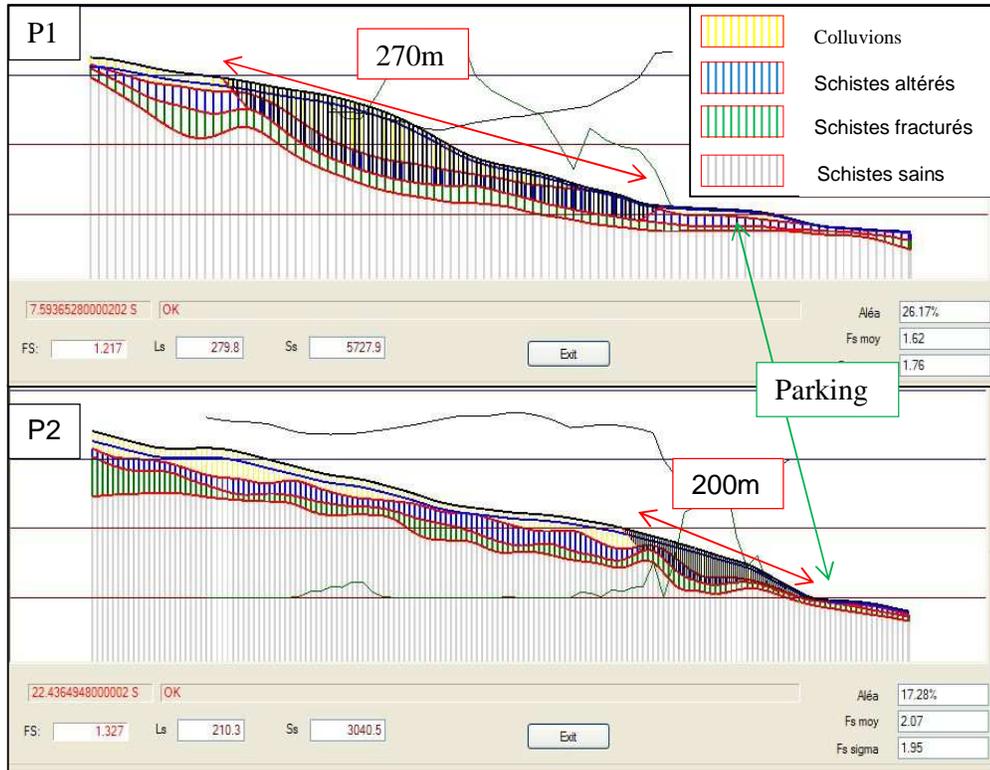
The computed profiles of Figure 22 show that for a landslide of 270 m in length along P1 and of 200 m in length along P2, the failure surface having the highest probability of occurrence reaches the topographic surface in the middle of the parkinglot. This is also the case for a 500 m length landslide along P2.

Figure 22.- Computing profile of ALICE® software along P1 and P2. Notice the geological model of illustration 3. Black hatched parts represent the landslide that has the highest probability of occurrence calculated along the profile. Notice that on both profiles, the failure surface is following the interface between the weathered and fractured shales to reach the surface at the level of the parking lot.

The modelling is also consistent with: 1) two imbricated landslides, one of 500 m length and the second of 250 m length, starting at mid-slope and 2) a failure surface located at the interface between the weathered and fractured shale reaching the topographic surface at the level of the parkinglot.
