Article

The Long-Term Hydrological Performance of Permeable Pavement Systems in Northern Spain: An Approach to the “End-of-Life” Concept

The experimental site of “Las Llamas” is a car park located in the city of Santander, Northern Spain. Santander has a Cfb climate (warm temperature, fully humid and warm summer) based on the Köppen–Geiger classification for world climates [16], with an average annual temperature of 15 °C and 1136 mm rainfall [17]. Northern Spain presents the highest average number of days with rainfall events above 1 mm in the country (125–150 days/year) [18].

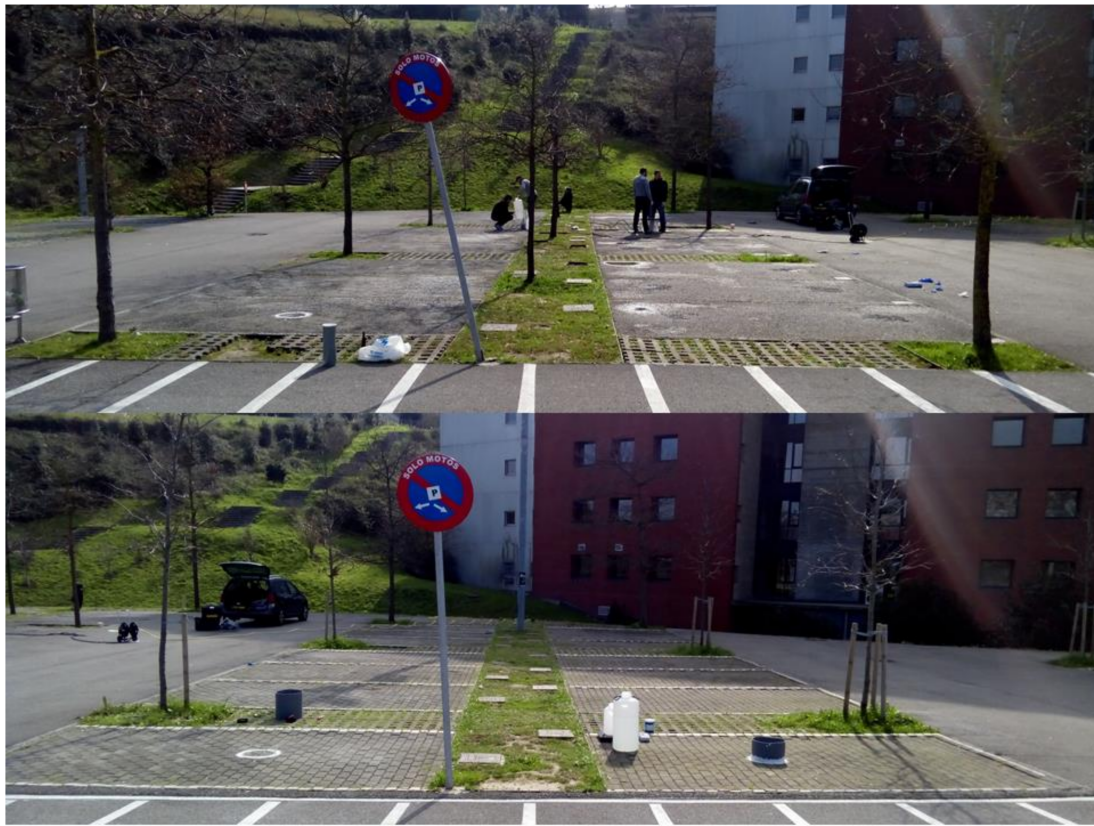
Figure 1. Car park bays subjected to the experiment between 2008 and 2018: upper image, PMPC (left), PA (right); lower image, ICBP-1 (left) and ICBP-2 (right).

The study area consists of 37 car park bays utilising porous mixtures and ICBP; the surfaces were designed and constructed to receive direct rainfall for research purposes at that time. The approximate impervious/permeable ratio for each surface is 1:1. However, it is important to remark that runoff from impervious areas drained towards conventional drainage systems and not towards the permeable pavement bays in all cases, which influences the sediment deposition patterns and thus the clogging processes. Polymer-Modified Porous Concrete (PMPC) was utilised as the surface layer in nine parking bays with 80 mm depth, whilst nine other parking bays had 80 mm depth PA, and the remaining 17 bays had ICBP as a surface layer with two different designs (80 mm and 100 mm depth). All the experimental bays were 4.2 m long and 2.4 m wide (Figure 1), representing a permeable area of

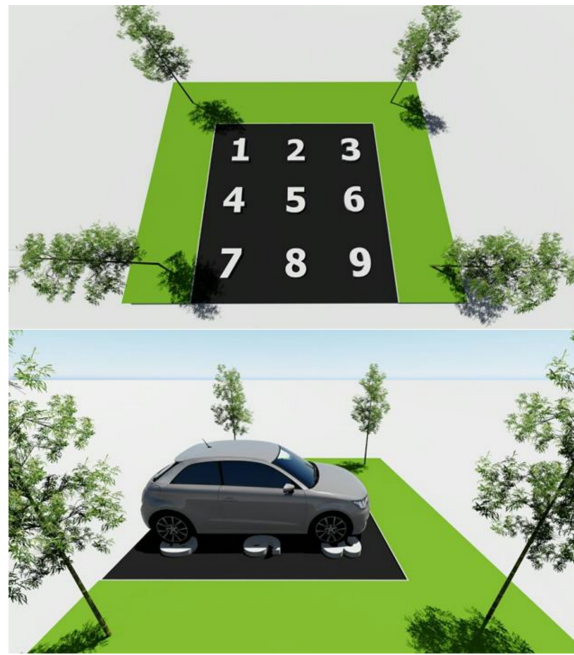
Figure 2. Numbering system for the zones in each car park bay where tests were performed and the common position of a car parked in the bay.

The central zone of each car park bay (number 5 in Figure 2) was taken as a reference to measure the permeability as it was previously found that the middle part of the bay was that of higher infiltration capacity in this experimental site [19]. In addition to this, eight extra points were measured at the porous-mixture surfaces with the aim of identifying potential differences in the hydrological performance of each bay due to the car parking, as was found by [19] (Figure 2).

It was found that the zoning described in Figure 2 significantly influenced the permeability in the PMPC surface, though not producing significant differences in the PA surface [19]. Therefore, porous-mixture surfaces that used PMPC were liable to lose their infiltration capacity due to a static vehicle load.

The same analytical and statistical approach was taken after eight years (Section 3.1.2) [19]. No significant differences were found between zones (Figure 2) after eight years ($p < 0.05$) due to the important loss of permeability, which averaged all values down to a low infiltration capacity near the hydrological “end-of-life” concept. Only the central zone (5 in Figure 2) maintained a significantly different value. This followed on from what was found by [19] after five years of operation.

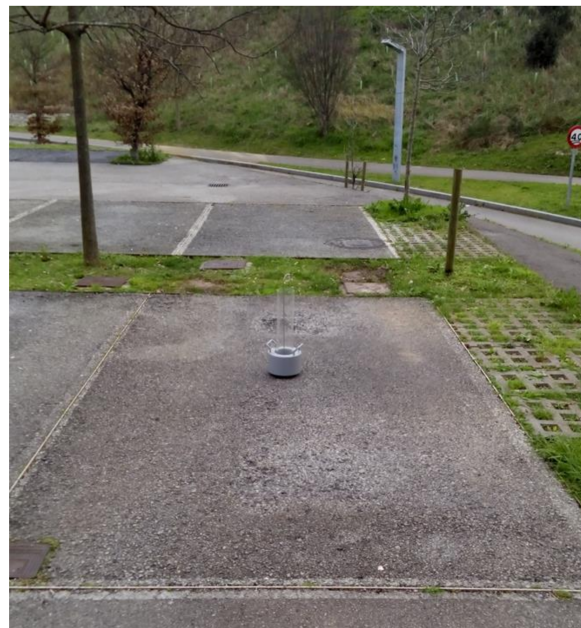
Figure 3. LCS Permeameter ready to begin the NLT-327/00 test on porous-mixture surfaces.

The standardised device used in this test is the LCS Permeameter (Figure 3).

1. LCS Permeameter. The device was placed at the point where the test was going to be developed, placing the weight on top of the LCS base.
2. Pre-wetting. Water was poured into the LCS up to 15 cm over the upper mark. Then, the water was allowed to infiltrate in order to saturate the pavement.
3. Testing. Water is poured into the LCS again up to the same point from the pre-wetting and measurements are taken of the time until the level of the water reach the lower mark of the device.

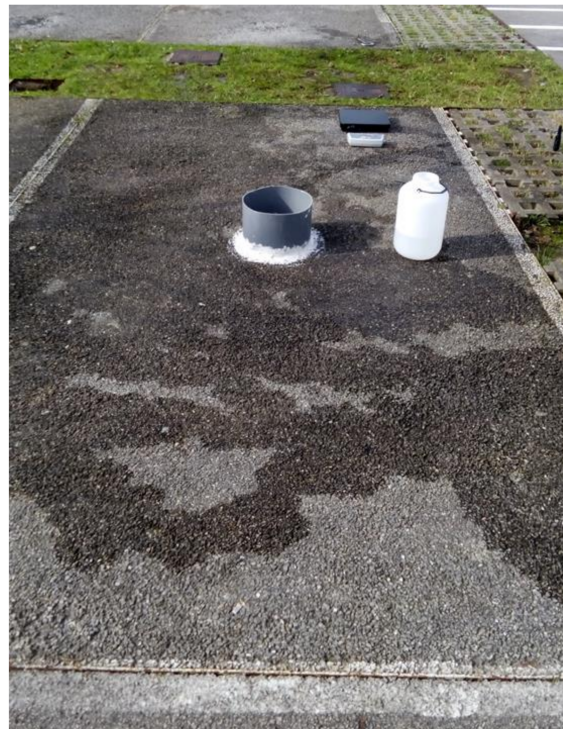
Figure 4. Preparation of the infiltration ring for the ASTM C1701/C1701M-09 test on PMPC and PA surfaces.

The Infiltration Ring (Figure 4) is the apparatus used to perform this test. This field device must be watertight and rigid and shall have a diameter of 300 ± 10 mm with a minimum height of 50 mm. In the case of this study, a PVC tube 310 mm diameter and 300 mm height was used.

4. Infiltration ring installation. The pavement surface was cleaned and plumber's putty was applied around the bottom edge of the infiltration ring in order to seal its perimeter.

5. Pre-wetting: 3.60 kg of water were poured into the ring, maintaining a constant head of water between 100 and 150 mm from the pavement surface. We measured the time taken between the water coming into contact with the surface and it fully infiltrating the pavement.
6. Test. The test started within 2 min after the pre-wetting stage; 3.60 kg of water were utilized again when the elapsed time measured during the pre-wetting stage was above 30 s. Otherwise, 18.00 kg were poured into the ring. The time was recorded following the same procedure indicated in the previous step.

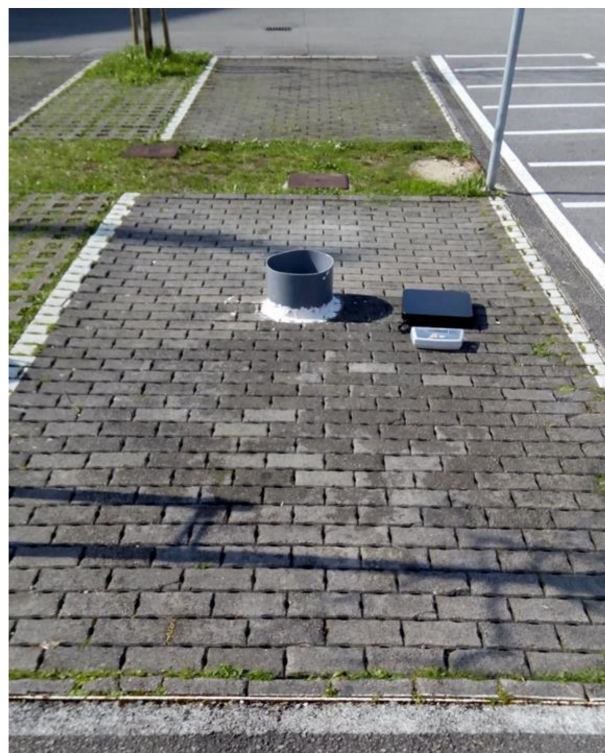
Figure 5. Setup of the infiltration ring for the ASTM C1781/C1781M-15 test on the ICBP surfaces.

This Standard Test Method [30] provides the field surface infiltration rate of in-place permeable unit pavement systems with solid interlocking concrete blocks paving units such as the two ICBP designs used in this research (ICBP-1 and ICBP-2). These tests were therefore performed in both ICBP designs for a total of 19 car park bays (Figure 5).

The test followed the same steps described in the ASTM C1701/C1701M-09 standard test (Section 2.3.2) and the permeability was calculated using Equation (2).

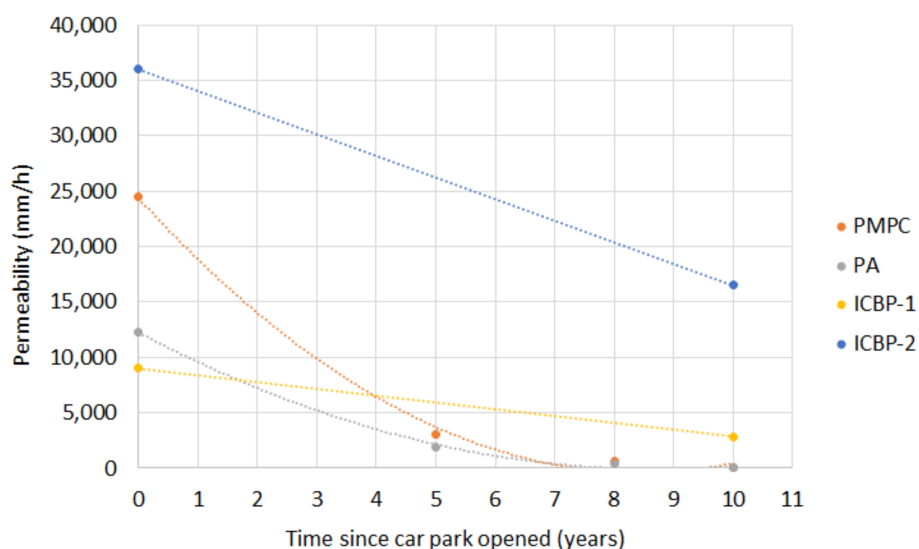
Figure 6. Evolution and trend lines for the permeability depending upon the PPS surface.

Trend lines for the reduction in permeability for each PPS surface be seen in Figure 6 and Table 6. Also, the range of time when each surface reaches 0 permeability can be seen in Table 6.

Porous-mixture surfaces presented less resilience to clogging than ICBP surfaces in all cases (Figure 6). For instance, PA presented a lower infiltration capacity than the ICBP-1 surface after 2 years since the car park was opened and with no maintenance. However, PMPC kept higher values of permeability than the ICBP-1 surface until four years. In conclusion, porous mixtures provided a high permeability rate over the first four years and became less competitive than the ICBP-1 surface after that time with no maintenance. On the contrary, ICBP-2 showed better permeability than both porous-mixture surfaces since the beginning of its operational life.
