# SAFE COMPOSITE BIKE HANDLEBAR

Group Project

Final Report

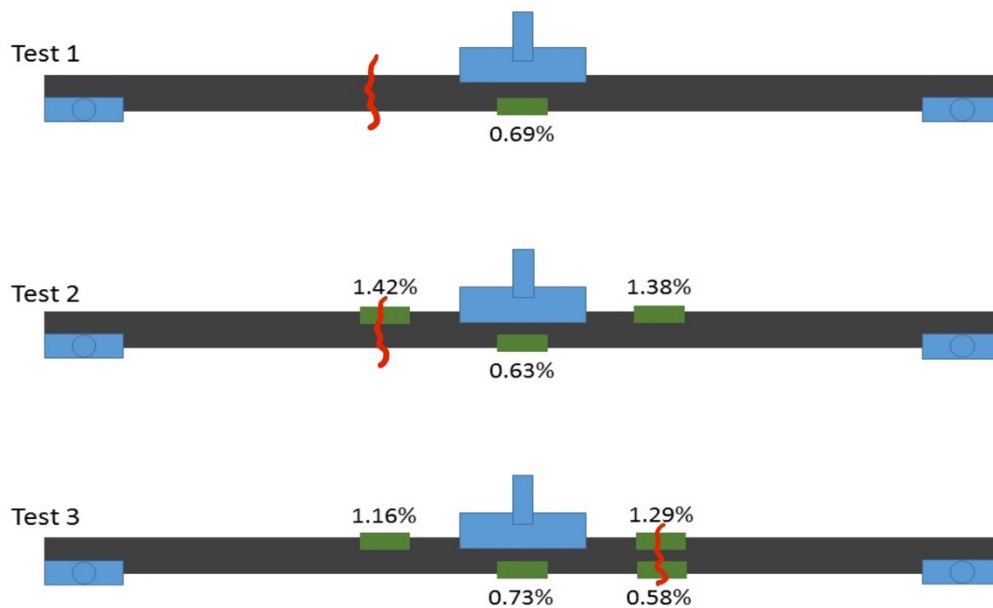
The red line represents the section where the tube broke in each test. It can be appreciated that the three tubes broke more or less at the same distance of the edge of the nose (18 mm). The fracture was initially expected to occur in the middle of the tube as the bending moment in a 3-point bending test reaches its maximum in that point. Nonetheless, after the tube was tested, the failure point was located near the ends of the loading nose. With this in mind, it can be concluded that our test was effectively a 4-point bending test because, as the tube was bending, the contact with the surface of the nose gradually decreased until all the load was concentrated on its two edges.

Figure 10: Maximum strain measured in the initial tests

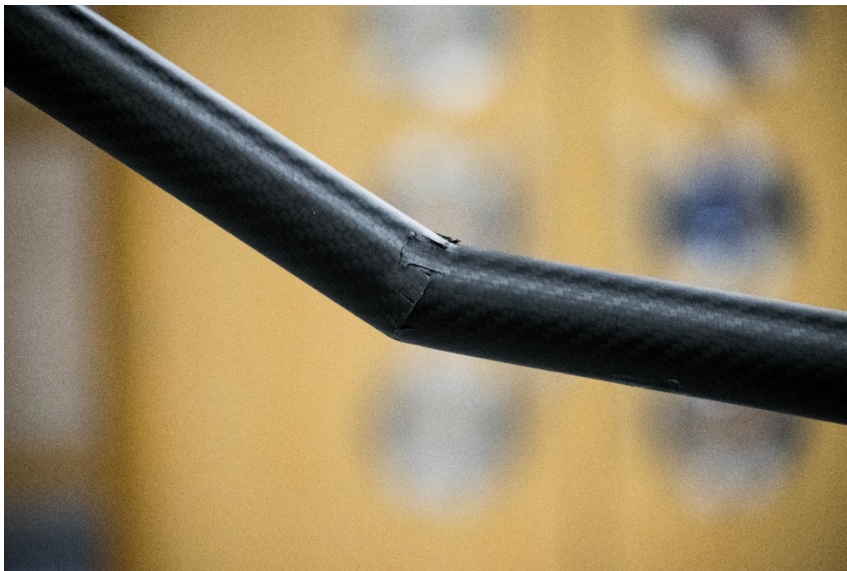
a big noise. After this catastrophic failure, the tube was divided in two parts, only slightly connected with each other on the tensile side. This confirms our prediction that the failure started on the compressive side, and then propagated through the entire section. Looking at the Figure 10, it can be understood why the tube did not break completely on the tensile side: the strain on this region was not high enough to complete the break. The Figure 11 shows this scenario.

*Figure 11: Initial test result in one tube*

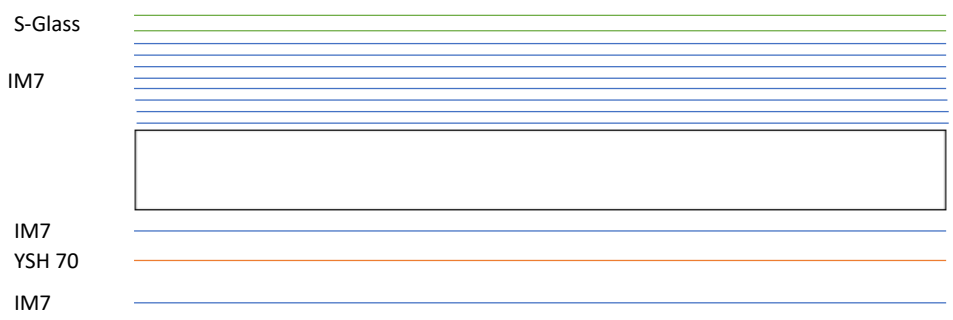
This layup was composed by S-Glass and IM7 on the compressive side and IM7 and YSH 70 on the tensile region.

Figure 23: First layup design

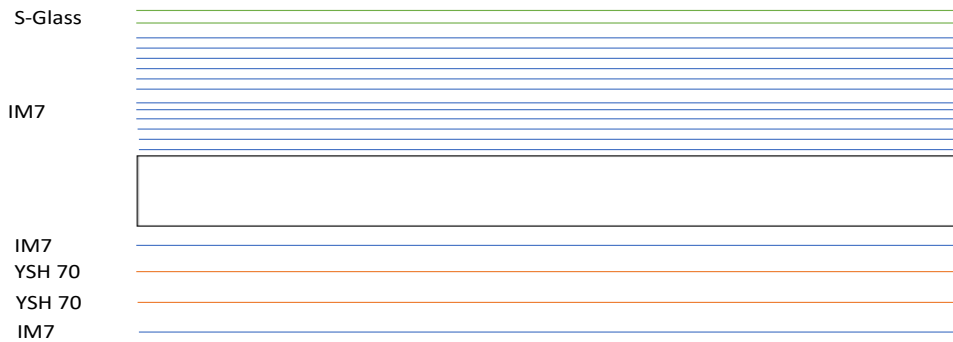
For the second layup, a second YSH 70 was added on the tensile zone and four IM7 in the compressive one. The final result was the layup that is shown below.

Figure 28: Second layup design

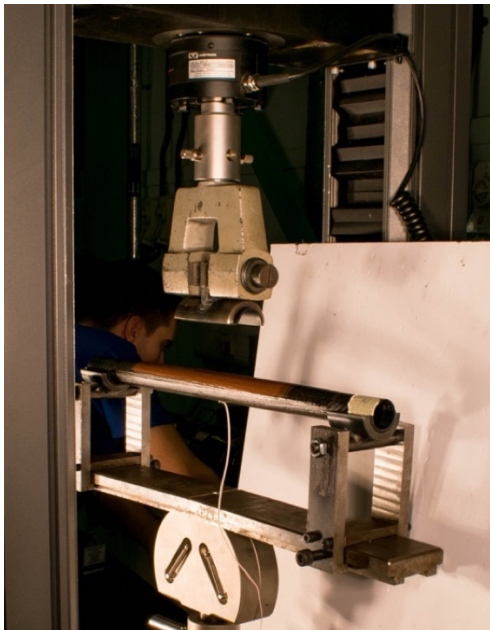
The setup of this test is shown in Figure 36.

*Figure 36: Test 1 set up*

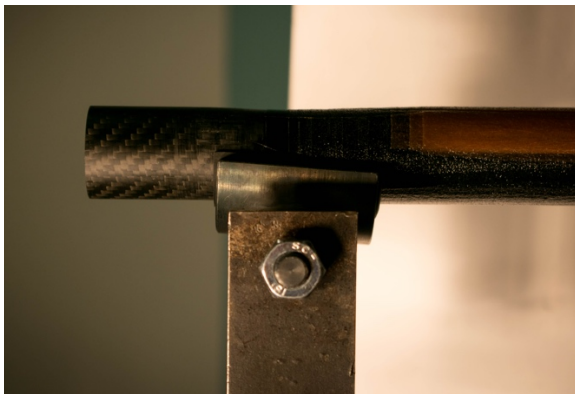
Finally, after thinking thoroughly about this, the testing team took the decision of reducing the span from 450 mm to 350 mm, having now this region over the supports' surface. The decrease of the aspect ratio was taken into account, being in any case higher than 10. This new setup is shown in Figure 39 and Figure 40.

*Figure 39: Test 2 set up, detail on the support*

*Figure 40: Test 2 set up*

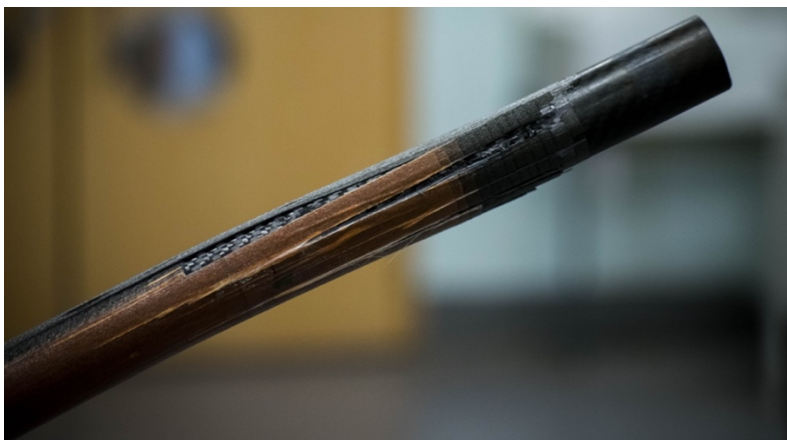
After the break, the tube remained in one piece. Figure 42.

Figure 42: Test 2 result on the tube

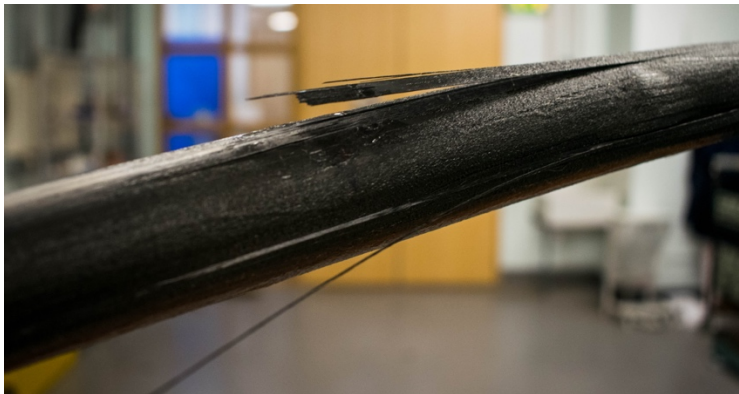
It can be seen in the initial set of tests the expected force displacement graphs for CF composites, a straight-line, occurring then the sudden failure. However, the second set of tests achieved a pseudo-ductile behaviour. Between force values of 0 and 7 KN the bar experiences elastic deformation. Beyond this point, the bar layup begins to fail before the tube. This curvature in the graph beyond 7 KN represents fibres within the YSH70 layers failing which results in loud cracking noises from the tube. This continues with fibre pull out and failure throughout the prepreg layers. This provides both visual warning with broken fibres fanning from the tube; sound of the fibres snapping and pulling out; as well as promoting greater deflection mirroring the behaviour of a yielding steel handlebar. This effect is shown in Figure 46.

*Figure 46: Peel off effect*

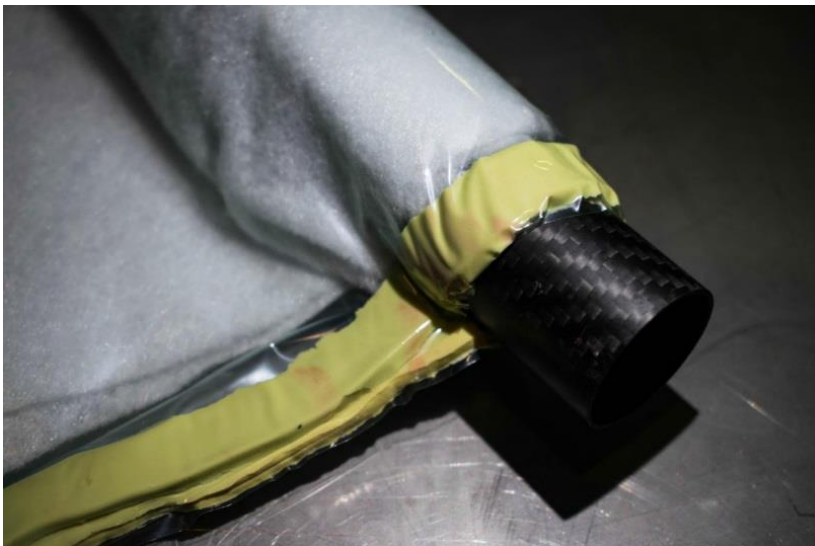
*Ilustración 5. Sellado del conjunto*

Inicialmente, las capas de los materiales se midieron y fueron cortadas a la longitud requerida. Acto seguido, se procedió al pegado de éstas sobre el tubo, procurando su correcta alineación. Una vez las capas se encontraban fijadas en la posición deseada, el conjunto se envolvió en una serie de materiales con los que se conseguiría un sello estanco, tal y como muestra la *Ilustración 5*. Después de la instalación de una válvula, se procedió a introducir la muestra en la autoclave, un horno capaz de calentar a temperaturas suficientes para el curado de las resinas de las capas de material preimpregnado. El autoclave aplica durante el proceso de curado presión, lo que permite que la adhesión sea satisfactoria. Para prevenir burbujas de aire en el interior de la bolsa se conectó una vía que aplicaba vacío durante el proceso.

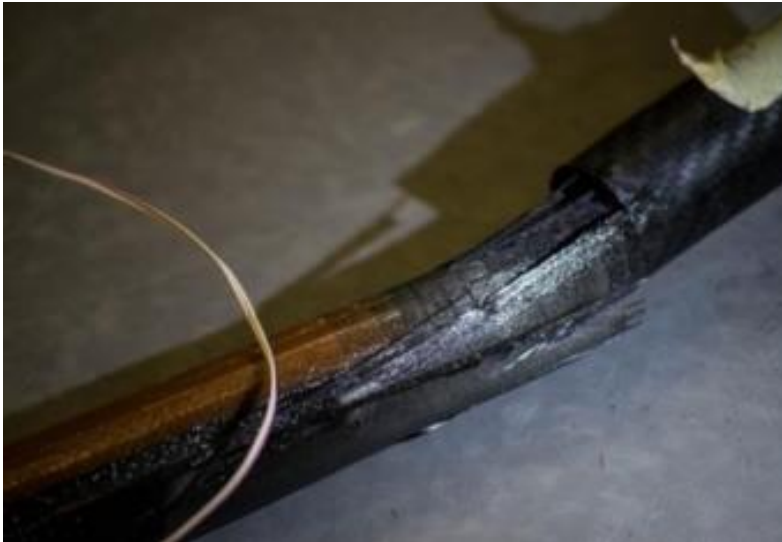
*Ilustración 6. Zona afectada Test 1.*

En la *Ilustración 6* se muestra el modo de fallo a cortadura del primer test. La rotura se originó en la zona donde terminaba el refuerzo. El concentrador de tensiones generado, unido al ejercido por los apoyos en la misma zona, acabó por debilitar el tubo antes de que el refuerzo hubiese realizado su función correctamente.

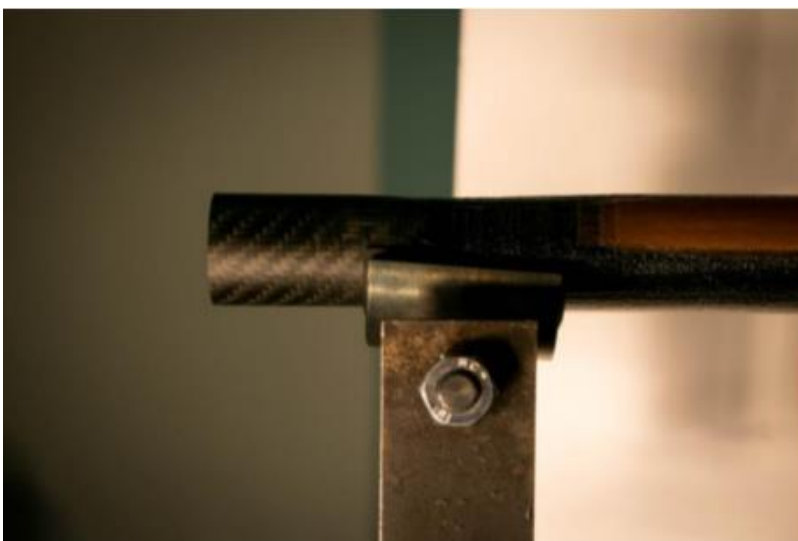
*Ilustración 7. Configuración de los apoyos en el Test 2.*

En el segundo ensayo se utilizó el mismo modelo de refuerzo. Con lo aprendido en el ensayo anterior se redujo la distancia de separación entre los apoyos, tal y como se muestra en la *Ilustración 7*. De esta forma se reducían los concentradores de esfuerzos en esa zona problemática sin refuerzo, pero, como contrapartida, se corría el riesgo de que la reducción de la relación de aspecto entre el diámetro del espécimen y la separación entre apoyos diera otros problemas. No obstante, se consideró que era un riesgo asumible para el correcto desarrollo del proyecto y se acometió el ensayo.
