# Understanding the retreat of the Jurassic Cantabrian coast (N. Spain): Comprehensive monitoring and 4D evolution model of the Tazones Lighthouse landslide

Coastal cliff retreat  
Jurassic Cantabrian Coast  
Landslide monitoring  
Maritime storms  
Rainfall influence

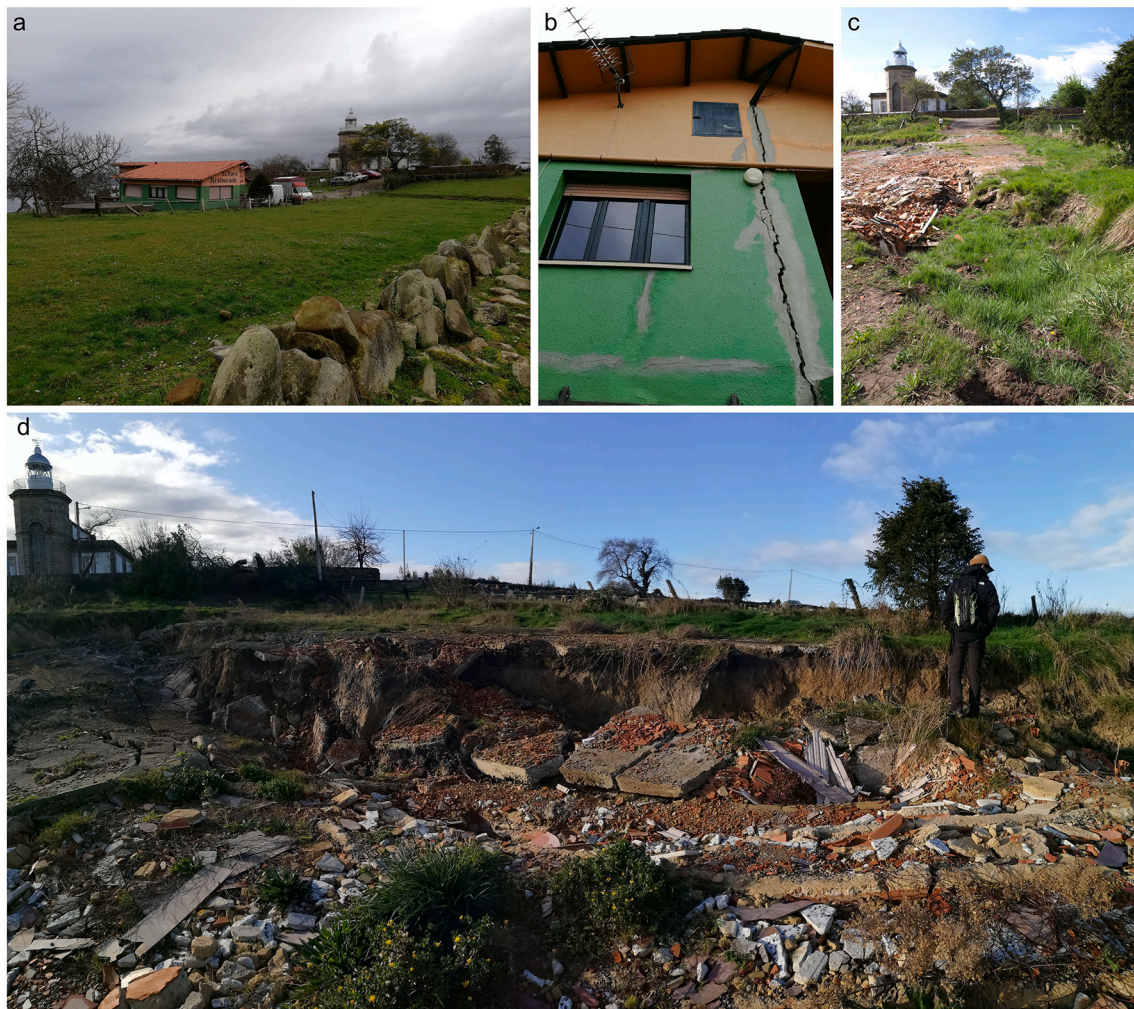
**Fig. 2.** a. View of the Tazones Lighthouse surroundings at the time of the restaurant eviction on February 20th 2018, after the critical enlargement of the cracks. b. Detailed view of the cracks in the restaurant building at the date of eviction. The presence of cement in the wall shows the attempt to repair old cracks that had developed before. c. d. Two views showing the evolution of surface cracks in the Tazones Lighthouse area on April 26th 2019 and January 17th 2020, respectively.

The cliff is active and instability processes occur every year in the vicinity of Tazones, both close to the sea and further inland. Sometimes gravity processes involve large volumes of rock, with deep cracks appearing at the surface. These events and signs have been detected by local people and researchers (Valenzuela et al., 2017; Domínguez-Cuesta et al., 2019), but until recently they had not been described in detail. Since 2018, a multidisciplinary research team has carried out monthly monitoring of 38 control points around the cracks that affected the area near the Tazones Lighthouse (Fig. 1) (Domínguez-Cuesta et al., 2020b). Some of these cracks are recognizable in aerial photographs taken since 1984 (López-Toyos et al., 2021), but have been pervasive since 2018, with accelerated movement and damage to the structural integrity of a restaurant and the abandonment of some agricultural and livestock/grazing land (Domínguez-Cuesta et al., 2019, 2020b). For now, none of the other buildings in the neighbouring town of Villar are affected. Within the study area, there are only three constructions: a vacation house, a lighthouse and the ruins of the mentioned restaurant (Fig. 2).

The most important geomorphological evidence of slope movement in the study area is given by the open cracks, which appear in the upper part of the slope (Figs. 2–5). Our first visit to this area was in February 2018, during the eviction of the restaurant due to the recent appearance of open cracks in the walls that irreversibly affected the structure of the building (Fig. 2a and b). We noticed the presence of old cracks filled with

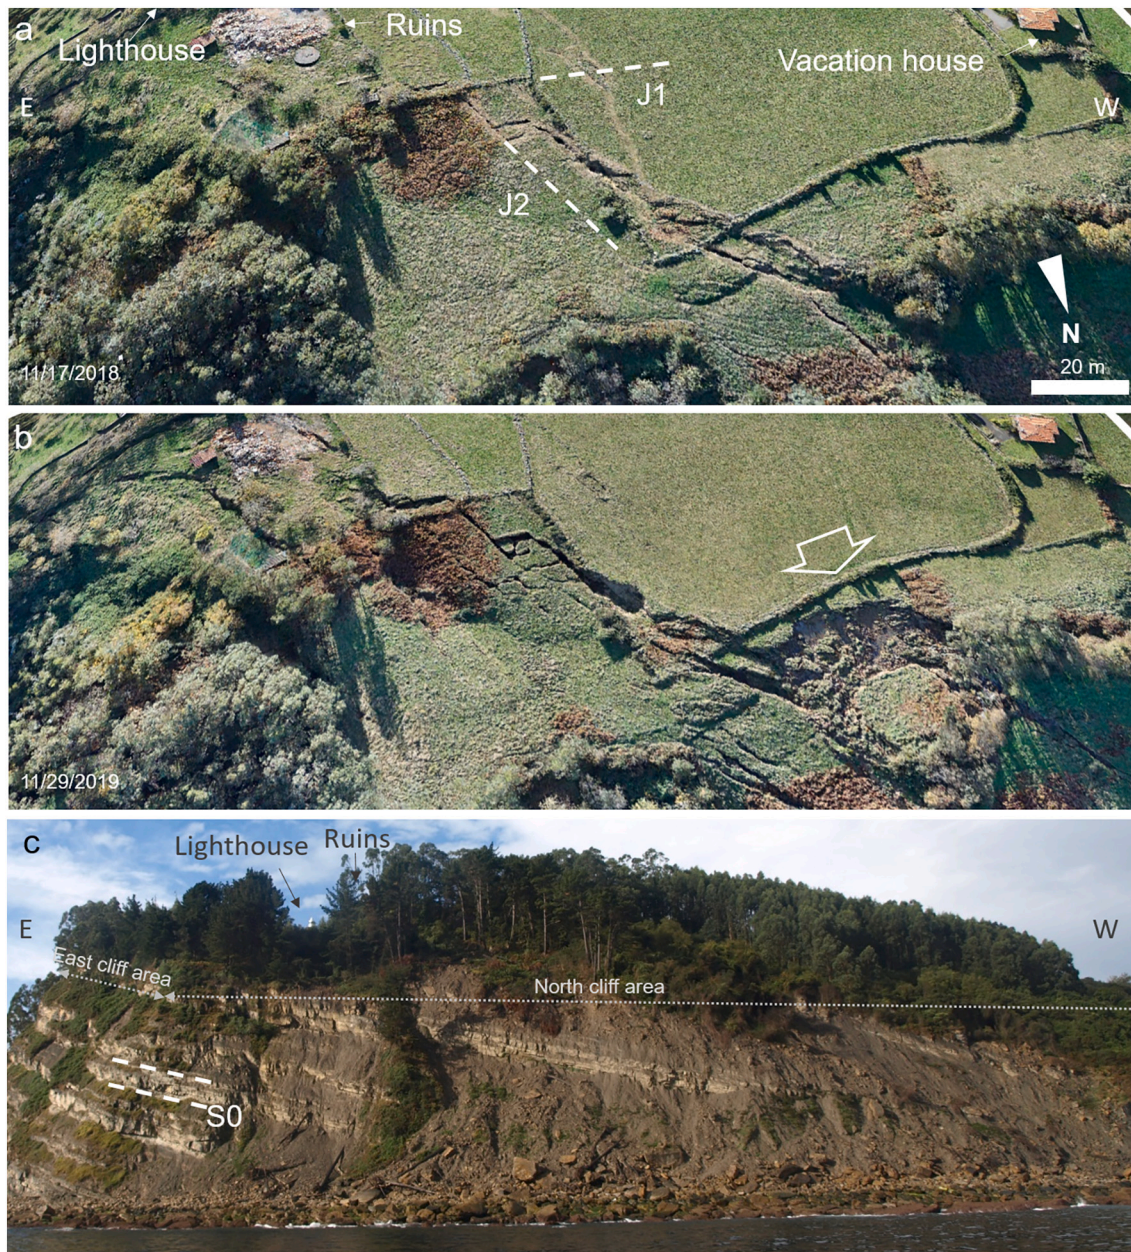
**Fig. 5.** Tazones Lighthouse slope evolution illustrated on the drone flight imagery of: **a.** 2018 and **b.** 2019. Main families of joints (J1 and J2) are shown. A surficial planar slide is indicated by the arrow. **c.** View of the cliff from the sea showing some detached metric-sized blocks and trees.

In the cliff sector, there are two well-differentiated areas (Figs. 4 and 5). In the eastern area, the cliff is steep and presents outcrops of layers of

deposits, pointing to a complex evolution that combines rock fall, topple, slide and flow processes (Figs. 4 and 5c). Nevertheless, at present, the most outstanding evidence of movement is given by open cracks, whose temporal evolution is shown in Figs. 5a and b and 6. Some of the cracks were already partially visible in the 2001 Google Earth images, and traces of possible cracks can be perceived in aerial photographs since the mid-80s (López-Toyos et al., 2021).
