The measurement and prediction of surface quality by new developments in EMATS and scarfing and the effect of scarfing on surface defects through the mills

PROJECT REPORT

Corus UK Limited

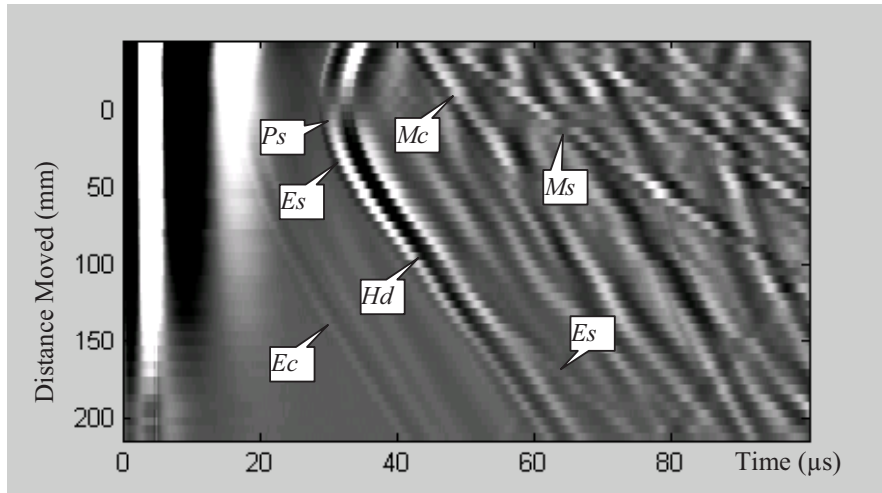
Fig. A1.14: Arrival times of edge shear waves and head waves at depth 90 mm

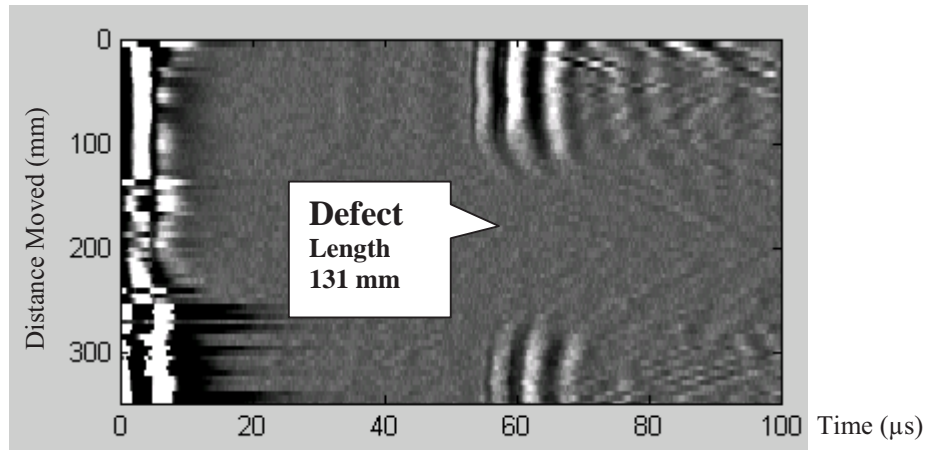
Fig. A1.15: Measured B-Scan image using EMAT-EMAT through method, showing reflection of head waves from a defect
The receiving linear EMAT is 10 mm long by 5 mm wide

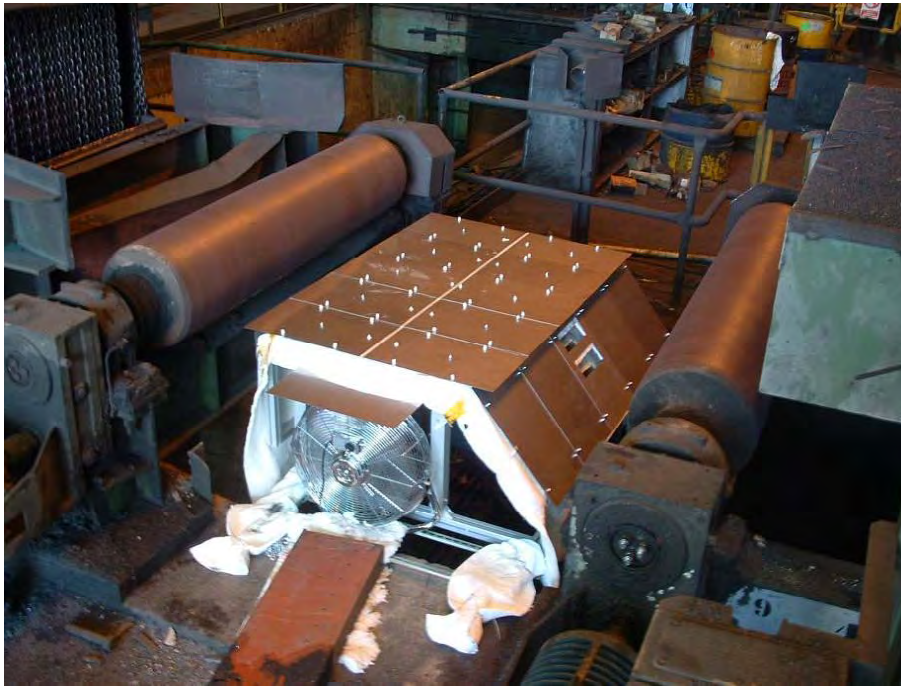
Fig. A2.8: Set-up of the conoscopic sensor for slab bottom face crack inspection: (a) arrangement of elements and (b) external view showing the glass windows

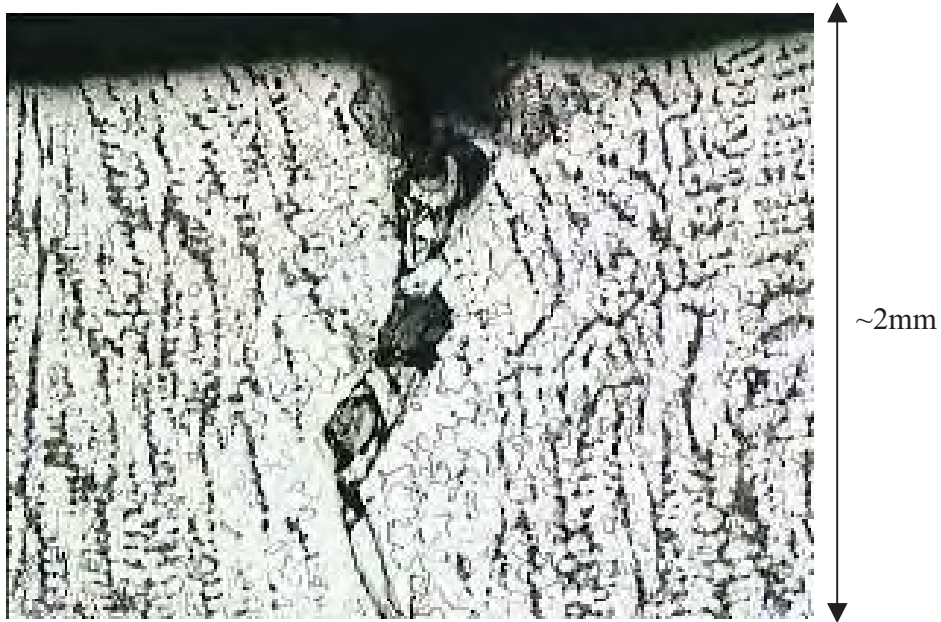
Fig. A4.15: Photograph of crack networks from Fig. A4.12, cast 60933, slab 5B, sample 1 after deep etching to remove scale

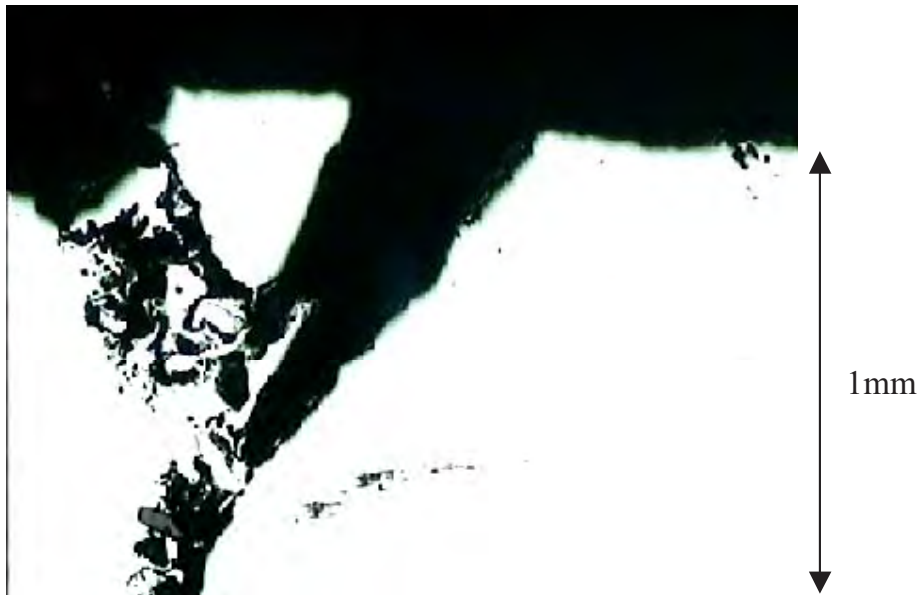
Fig. A4.16: Cross-section and microstructure of crack networks, cast 60933, slab 5B, sample 1, after etching, x50

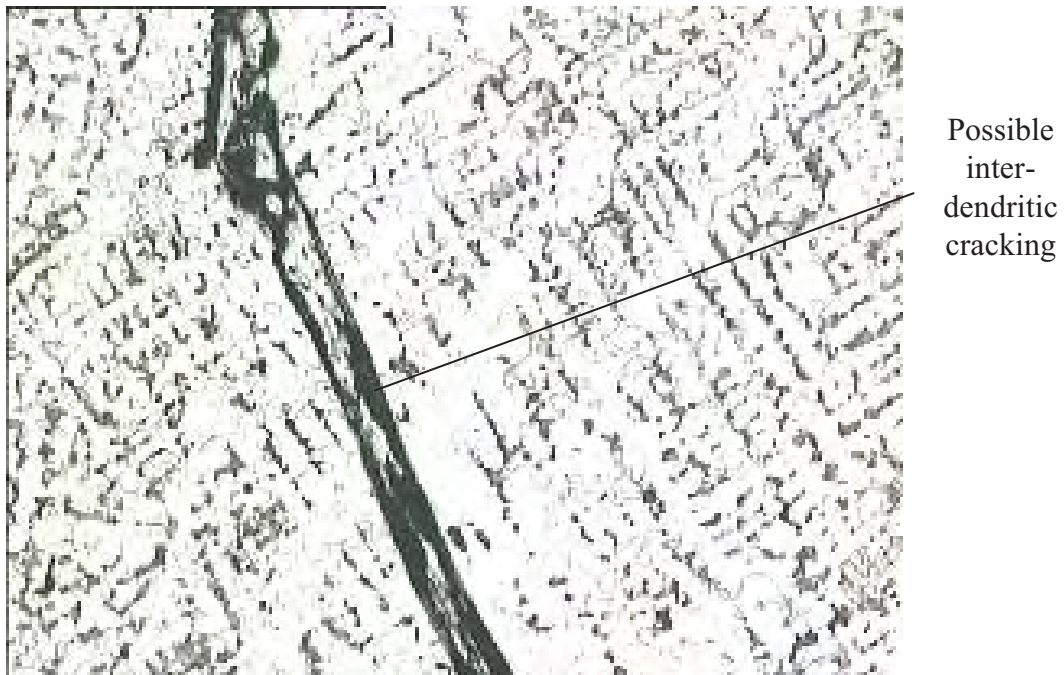
Fig. A4.21: Photograph of cracking from Fig. A4.14, cast 60942, slab 5B, sample 5 after deep etching to remove scale
