Nondestructive Evaluation of Carbon Fiber Bicycle Frames Using Infrared Thermography

Abstract: Bicycle frames made of carbon fibre are extremely popular for high-performance cycling due to the stiffness-to-weight ratio, which enables greater power transfer. However, products manufactured using carbon fibre are sensitive to impact damage. Therefore, intelligent nondestructive evaluation is a required step to prevent failures and ensure a secure usage of the bicycle. This work proposes an inspection method based on active thermography, a proven technique successfully applied to other materials. Different configurations for the inspection are tested, including power and heating time. Moreover, experiments are applied to a real bicycle frame with generated impact damage of different energies. Tests show excellent results, detecting the generated damage during the inspection. When the results are combined with advanced image post-processing methods, the SNR is greatly increased, and the size and localization of the defects are clearly visible in the images.

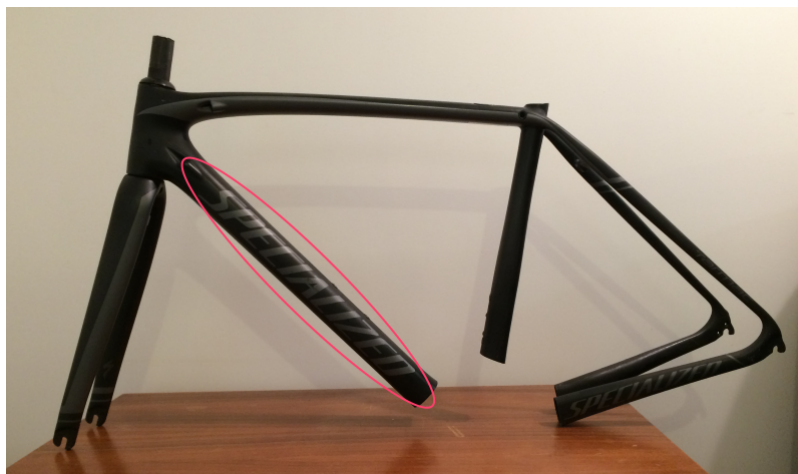
The bicycle frame used in the experiments has been manufactured by SpecializedTM, one the most popular high-performance bicycle brands. Figure 1 shows an image of the inspected carbon fibre bicycle frame. The materials used in this bicycle are common for a carbon fibre bicycle frame. Thus, the results in this work can be easily extrapolated to most bicycles made of CFRP.

Figure 1. Inspected bicycle frame.

The bicycle frame is made of carbon fibre with reinforcements in some areas where different tubes are connected. The thickness of the tubes in the bicycle frame varies from 1.4 to 1.8 mm due to the bending of the carbon fibre composite during manufacturing. Experiments were performed in the down tube (highlighted in the image), which is the tube that connects the head tube and the bottom bracket. This tube can be clearly identified in the image because it contains the name of the brand. This tube is very close to the front wheel, where stones from the road can be projected, causing impact damage.

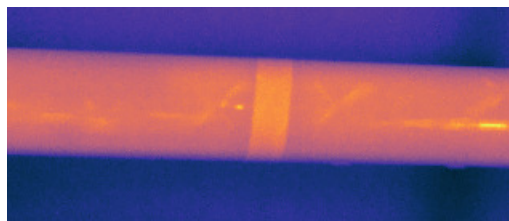
The emissivity of the surface of the bicycle frame has been estimated using the reference emissivity material method [22]. Based on this method, the bicycle frame is heated with a piece of electrical tape with known emissivity stuck on the surface. The reference temperature on the electrical tape is used to measure the emissivity of the surface of the bicycle frame. Figure 2 shows an infrared image acquired during the experiment to measure emissivity using a thermal colour palette [23].

Figure 2. Infrared image of the experiment to measure emissivity using an electrical tape stuck on the surface.

The result of the emissivity measurement procedure indicates that the global emissivity of the surface of the bicycle frame perpendicular to the camera is 0.82.

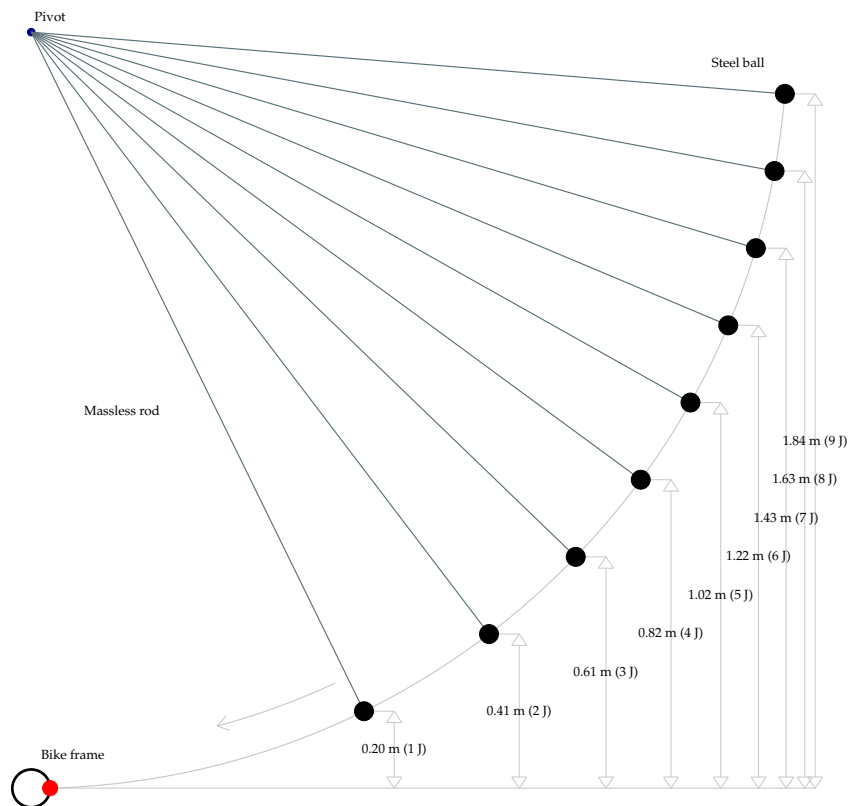
Impact damage is generated using a steel ball. The ball is designed and manufactured to perform the tests specified in different standards (IEC 60335, IEC 60065, IEC 60745, IEC 61029, IEC 60950). The ball is suspended from a pivot using a rod with negligible mass, creating a pendulum. The ball is displaced sideways from its equilibrium position with the rod fully extended. When released, the potential energy of the ball is transformed into kinetic energy, which is transferred to the bicycle frame during the impact. Figure 3 shows an illustration of the procedure to generate damage. The collision is considered elastic.

Figure 3. Procedure used to generate impact damage.

The energy of the impact depends on the mass of the ball, the height from the initial position to the impact position and the acceleration due to gravity. The ball used in the experiments is made of steel with a diameter of 50 mm and a mass of 0.5 kg. The acceleration due to gravity is also a constant.

Thus, by suitably adjusting the height of the ball, different impact energies can be generated. As can be seen in the figure, when the ball is at 0.2 m, the energy is 1 J, and when the ball is at 1.84 m, the energy is 9 J. These are the ranges of impacts generated in the bicycle frame: from 1 to 9 J, increasing by 1 J.

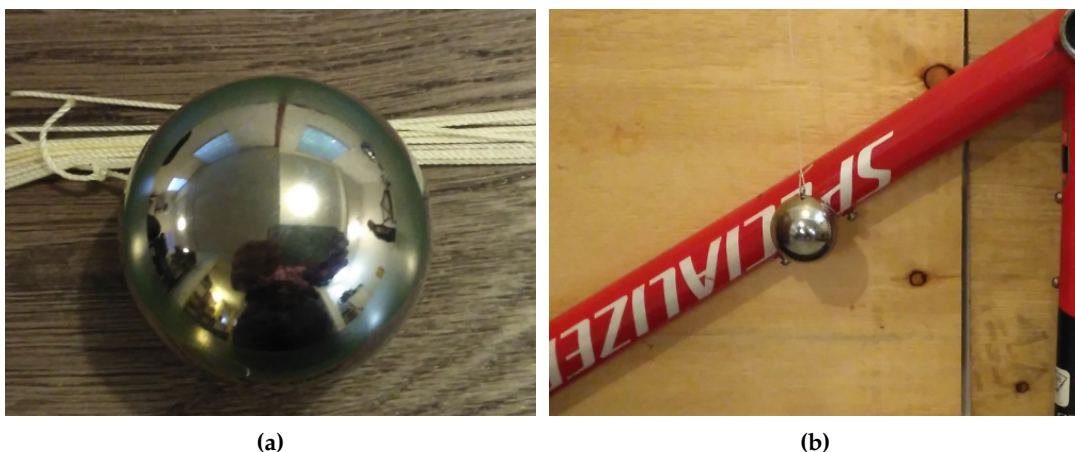
Figure 4 shows the calibrated steel ball used in the experiments. The position of the bicycle frame was suitably adjusted so the ball hit the frame close to the centre of the tube.

Figure 4. Calibrated steel ball used in the experiments. (a) Steel ball and rod. (b) Ball hitting a similar bicycle frame to produce impact damage.

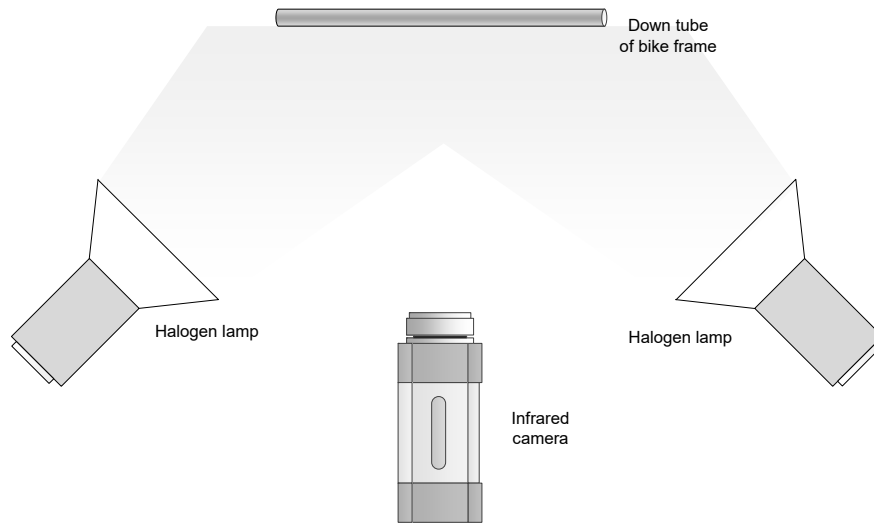
The experiments are performed in reflection, i.e., the halogen lamps and the infrared camera are on the same side. This is the most appropriate configuration when the defects are close to the surface. Figure 6 shows an illustration of the configuration used. As can be seen, halogen lamps are positioned at both sides of the camera, and the inspected tube of the bicycle frame is in the middle, receiving the stimulus from the two halogen lamps.

Figure 6. Infrared inspection in reflection mode.

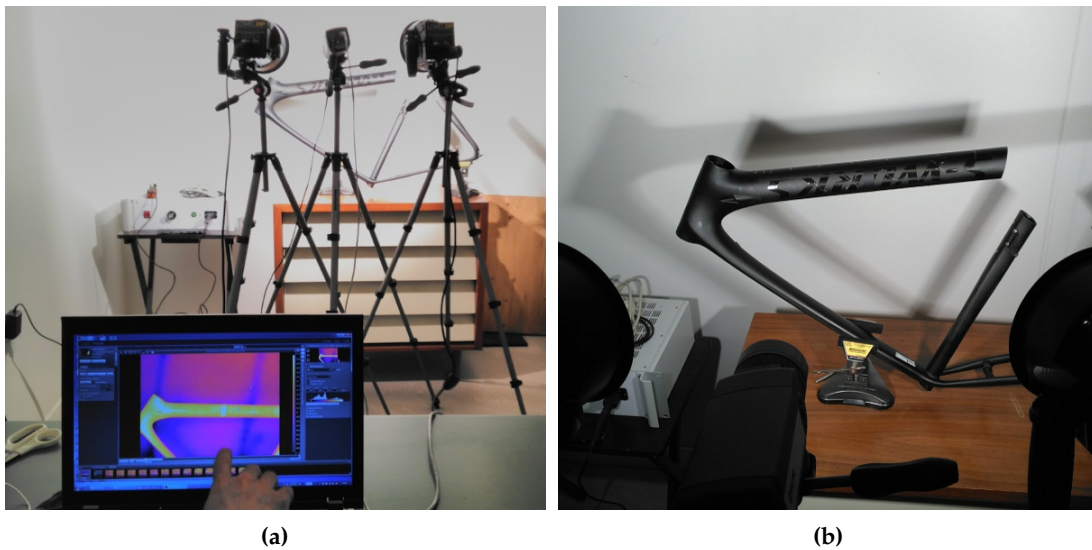
Figure 7 shows two images documenting the experimental setup. The bicycle frame was slightly rotated backward to reduce the reflections, as they can degrade the acquired infrared radiation by the camera. The camera and the halogen lamps are slightly tilted downwards as well to reduce the reflections of the halogen lamps on the bicycle frame.

Figure 7. Inspection of the bicycle frame. (a) Complete view. (b) View from the camera position.

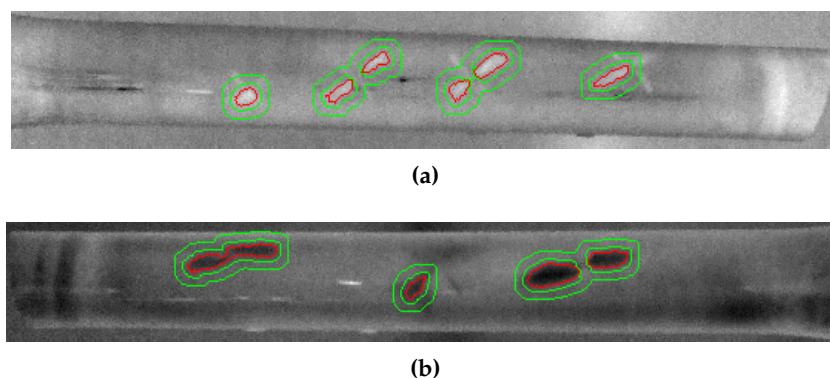
Figure 8 shows the obtained regions using the proposed procedure. The region in red is the defect region, and the region in green is the sound region. In this case, an image obtained with good contrast of the defects is used as a reference.

Figure 8. Defect and sound regions for the quantitative evaluation of the results. (a) Side A (from left to right, impact damage of 3, 4, 5 and 6 J). (b) Side B (from left to right, impact damage of 7, 8 and 9 J).

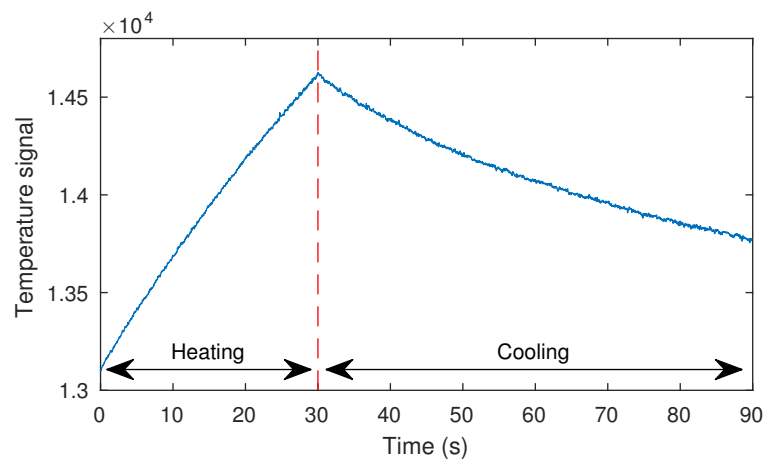
Before applying the post-processing methods, it is necessary to define the periods of interest from the infrared inspections. Two periods are considered in the optical step heating stimulation: heating and cooling. The periods are represented in Figure 9, which shows the temperature evolution of a pixel in the image after the thermal stimulus. In this case, a 30-s pulse configuration was used. The images in these two periods are extracted and analysed independently. The number of images extracted from the cooling period is always the same. However, in the heating period, the number of images depends on the time of the pulse.

Figure 9. Periods of time considered for the analysis.

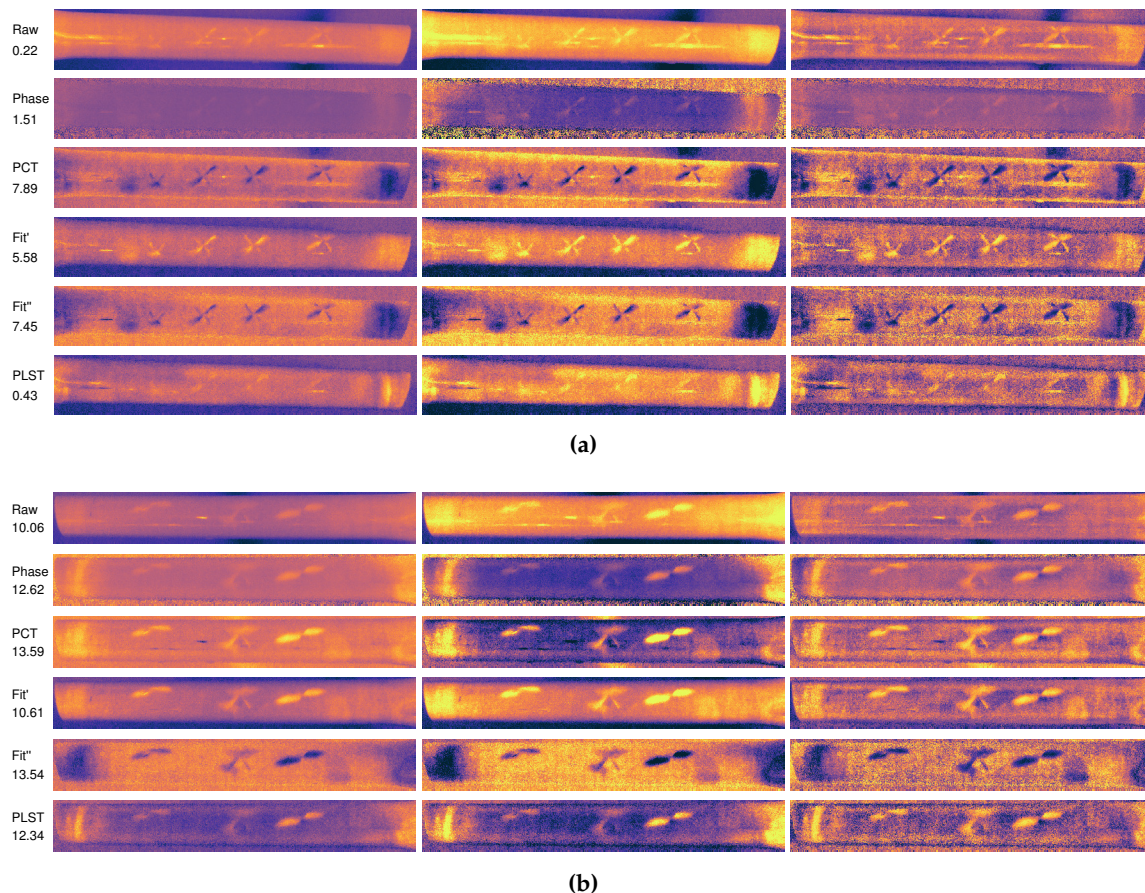
Figure 11 shows a comparison between the images obtained from the infrared inspection during heating, using a 10-s pulse and 2000 W. The first column shows the image where the best SNR was obtained for the raw sequence and the sequences resulting from image post-processing. The second and third columns show a contrast enhancement of the first image. The second column shows an image where the histogram has been stretched removing the intensity values below 2% and 98%. The third column shows the results of applying a contrast-limited adaptive histogram equalization [34]. In these images, most of the impacts can be clearly distinguished. The only impacts that cannot be identified are impacts with 1 and 2 J. All the others can be clearly appreciated in the images, especially defects with high impact energy. As can be seen, the pattern of defects is similar to a butterfly wings pattern, where the direction is affected by the alignment of the fibres in the composite used for manufacturing the bicycle frame. This pattern is commonly found in infrared inspections of impact damage [3,35,36].

Figure 11. Images resulting from the infrared inspection during heating using a 10-second pulse and 2000 W. (a) Side A with impact damage from 1 to 6 J. (b) Side B with impact damage from 7 to 9 J.

Low energy impacts (1 and 2 J) are not detected in the resulting infrared inspection. Those low energy impacts may have simply not created any damage, in which case it is normal to not detect them, or the limit of detection was reached using this specific setup. These type of impacts may be detected using infrared cameras with higher sensitivity. However, further exploration should be performed to analyse the detectability and consequences of this type of impact in the bicycle frames, or if they are causing any integral damage at all.

The results in Figure 10 and the images in Figure 11 also show a huge difference between the raw sequence and the results of the post-processing methods. The raw images have a very low SNR,

while the post-processing methods greatly increase the resulting SNR, providing images where the defects can be appreciated easily. Therefore, the selected post-processing methods are helpful in improving the visualization and localization of the defects caused by impact damage.

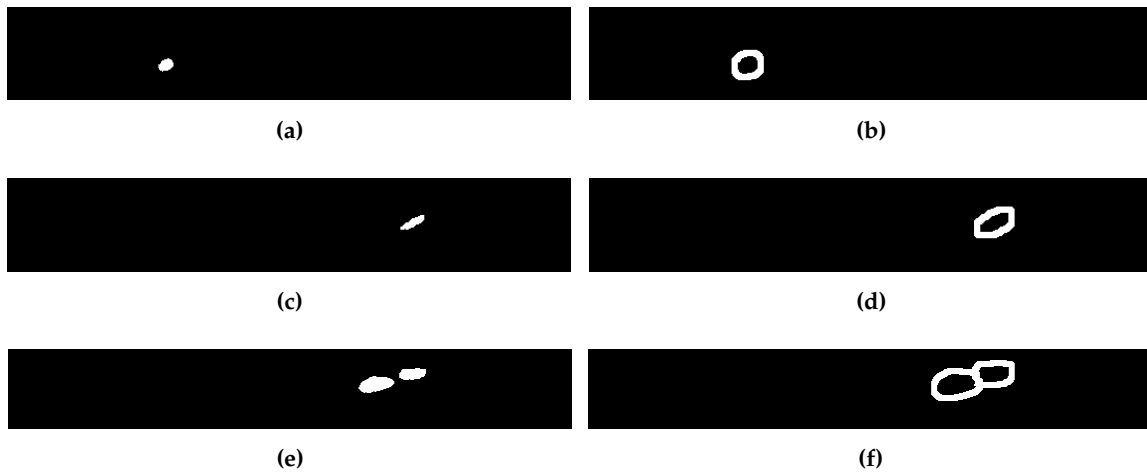
The calculated SNR in these results is an average of the SNR in all defects for each side. In order to evaluate the SNR of single defects, new regions for the defects and for the sound areas have been defined using the same procedure described above. Figure 12 shows the binary images of the defect and sound regions for the defects with impact damage of 3, 6 and 9 J.

Figure 12. Defect and sound regions for defects with impact damage of 3, 6 and 9J. (a) Defect region for 3J impact. (b) Sound region for 3J impact. (c) Defect region for 6J impact. (d) Sound region for 3J impact. (e) Defect region for 9J impact. (f) Sound region for 9J impact.

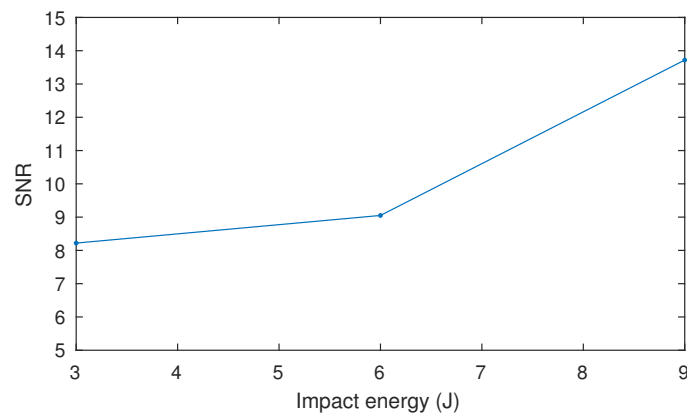
The SNR for these three defects is represented in Figure 13, which indicates that the SNR increases with the impact energy. This result is consistent with previous works on the topic, which indicated that the intensity in the images increases with the impact energy [14]. Figure 14 shows the images of these three defects. The images are on the same scale. Thus, this figure can be used to compare the size of the defects. The area of the defects is another feature that is correlated with the impact energy: defects caused by high impact energy are larger. The particular pattern of impact damage can be clearly observed in these images.

Figure 13. SNR for the three considered defects with impact energy of 3, 6 and 9J.

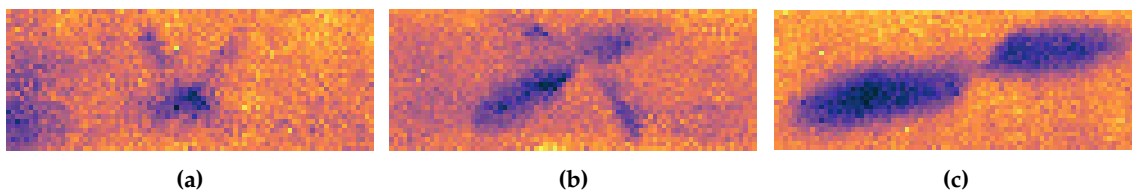
Figure 14. Images for the three considered defects. (a) Defect with 3J impact energy. (b) Defect with 6J impact energy. (c) Defect with 9J impact energy.
