## Bridge replacement due to structural obsolescence. The case of the Ciudad Real-Badajoz railway bridges (Spain)

**ABSTRACT:** The great railway bridges built in the 19th century are magnificent examples of the rise of civil engineering, and especially of the development of iron structures. Over time, however, the increase in railway rolling stock complexity and weight made some structures obsolete, and their replacement became indispensable during the 20th century. Such is the case of some bridges built in a section of the Spanish Ciudad Real-Badajoz railway line inaugurated in 1865, which crossed watercourses as important as the Guadiana River, the Aljucén River or the Gévora River. At two different times, during the 1920s and 1950s, the original iron lattice girder bridges were replaced by new concrete structures built in the same places. This study analyzes those structures, both old and new, and especially how the replacement construction was carried out without interrupting rail services. The original construction projects and the new bridges, some historic photographs of the replacement work, which include piers, formwork, arches and decks and dismantling of obsolete iron

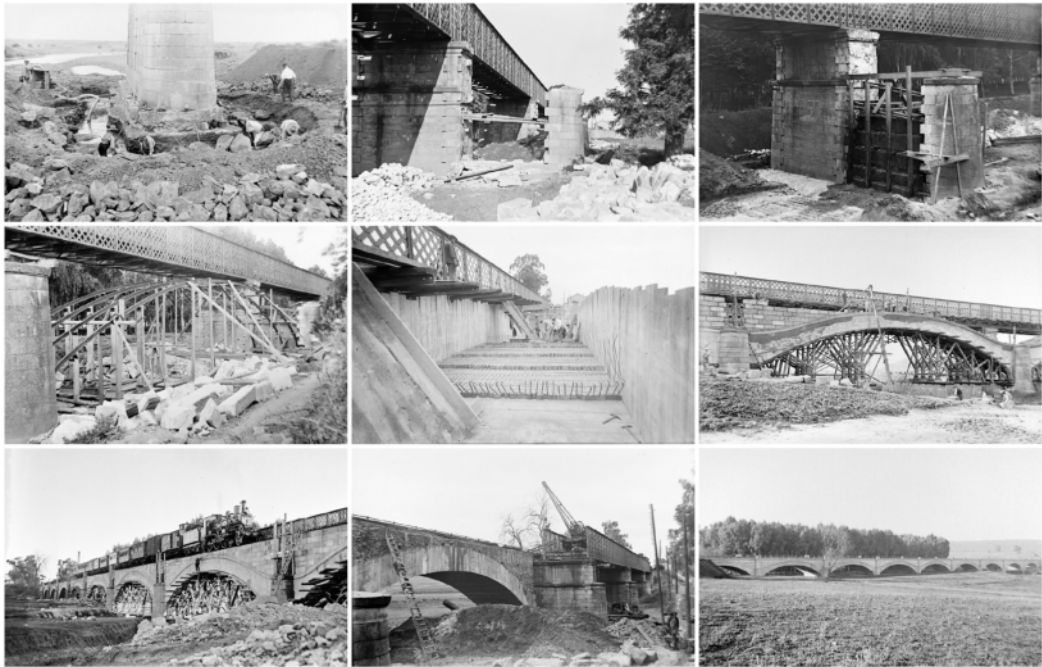
Figure 3. Aljucén Bridge. Top: soil excavation near the abutments; dismantled pier; rebuilt pier. Middle: centering; frame in the top of the arch; spandrel made of ashlars. Bottom: a train in the first half of the bridge; crane dismantling the metal bridge; new bridge already completed. Photos by Juan Salgado Lancha (AHF-MFM MZA- 0232-IF\_10-20-; MZA- 0276-IF\_10-23-; MZA- 0282-IF\_10-23-; MZA- 0284-IF\_10-23-; MZA- 0271-IF\_10-22-; MZA- 0235-IF\_10-20-; MZA- 0241-IF\_10-20-, MZA- 0250-IF\_10-21-; MZA- 0229-IF\_10-19-). The collection consists of 64 photographs taken from 29.09.1926 to 05.11.1929.

The first action taken was to reinforce the pier footings at both ends as arches of various spans, and therefore with different pressures, met at them. The foundations of the abutments were also reinforced, as was Pier 7. The excavation was done manually and water was pumped out to facilitate the work.

Then the first half of the bridge on the longitudinal axis was executed making use of the existing piers (the width, as mentioned above, was dimensioned to support a double track). Half of each pier was taken apart down to the footings, although the cutwater was kept, and later rebuilt with a new geometry, making use of the existing foundation.

Arch centerings were mounted on provisional concrete supports. They consisted of a triangulated wooden structure to which braces were added, supporting a total of four metal arches, with a series of battens placed over them. A total of five sets of centerings were used for construction. To facilitate mounting, a temporary wooden catwalk was built supported by the lattice girder of the existing bridge as a sort of brace.

Once the arches were concreted, the spandrels were closed off and filled in; the exposed side was closed with ashlar from the piers that had been dismantled and the other side was closed off with a temporary stone masonry wall. After these operations, the track was laid and the first half of the bridge, now completed between both abutments, was opened to traffic. With the new track now in service, the metal bridge was dismantled using a mobile crane. The scrap was removed, and space was thus left for construction of the second half of the bridge in accordance with the same procedure.

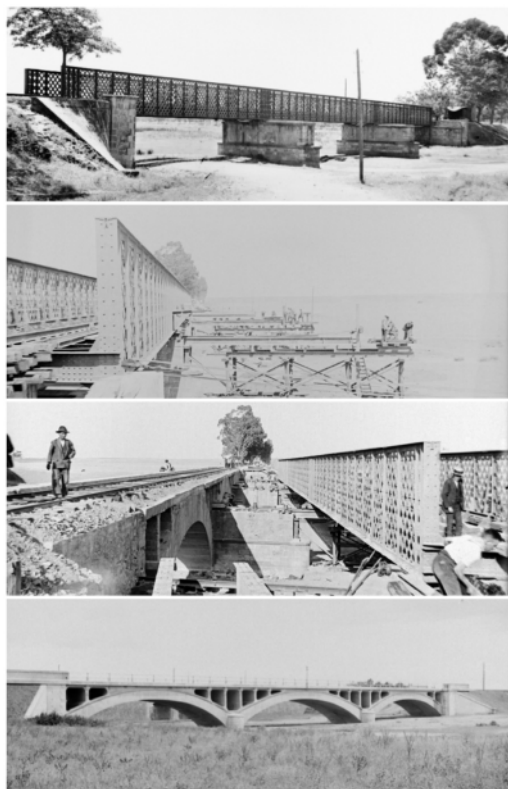
Figure 4. Gévora first bridge; temporary supports for metal bridge, first bridge moved; new bridge already completed. Photos by Juan Salgado Lancha (AHF-MFM MZA- 0356-IF\_10-28-; MZA- 0366-IF\_10-29-; MZA- 0364-IF\_10-29-; MZA- 0371-IF\_10-29-). The collection consists of 46 photographs taken from 20.06.1928 to 12.06.1930.

When the new track had been put into service, the metal structure was dismantled. Unlike the previous case, the first structure was moved sideways to temporary supports: in August and September 1929, it was dismantled and taken by train to the Seville and Villaverde Bajo to be scrapped. The metal sections replaced in the first bridge were estimated to weigh 169 tons, and in the second 294 tons, and the scrap was sold for 1.15 Pesetas per kilo.
