Short communication

Supporting proactive planning for climate change adaptation and conservation using an attributed road-river structure dataset

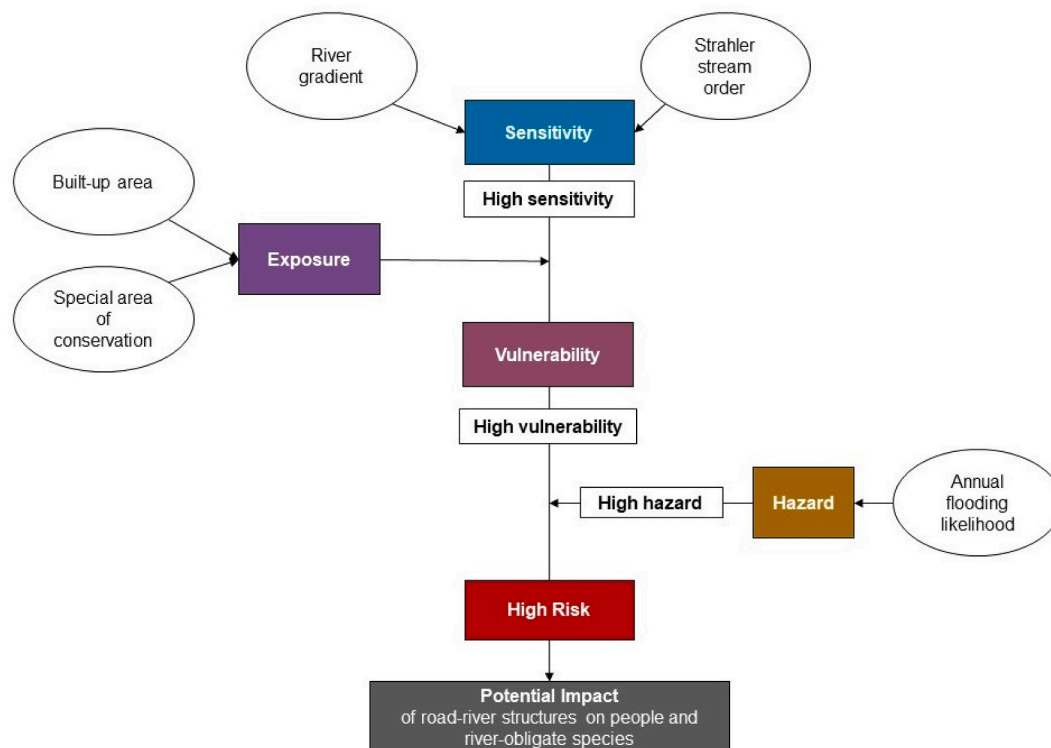
Fig. 1. Conceptual overview of screening-level assessment for culvert and bridge vulnerability (*sensitivity* + *exposure*) and risk (*vulnerability* + *hazard*) of potential structure impact on people and river-obligate species under flooding.

Risk of impact is described by IPCC (2014) as the interaction of hazards with the vulnerability and exposure of human and natural systems, and we adopted this characterisation in our screening-level assessment (Fig. 1). Using our ascribed structure dataset, our topologically corrected OS Open Rivers network, and other publicly available spatial data (detailed in the following paragraphs of this section), we undertook a screening-level assessment (Fig. 1) of culvert and bridge vulnerability (*sensitivity* + *exposure*) and current risk (*vulnerability* + *hazard*) of impact from flooding on environmental and social connectivity because of structural damage. We excluded fords from this analysis because these structures had low prevalence in the landscape and, by design, interact with rivers and flows differently to culverts and bridges.

We represented *sensitivity*, or the propensity of structure damage because of location, with the intersection of river size (Strahler stream order) and gradient (sourced from Januchowski-Hartley et al., 2021) (Fig. 1). Structures on smaller rivers and higher gradients are frequently damaged and tend to incur repeated repair costs (Gillespie et al., 2014; Januchowski-Hartley et al., 2014; O'Shaughnessy et al., 2016). We categorised all culverts and bridges as either low (1–3) or high (4–6) stream order and as either low ($\leq 5\%$) or high ($> 5\%$) gradient, where those with low stream order (≤ 3) and high gradient ($> 5\%$) had high sensitivity to damage. There were 98 structures ($< 1\%$) near river mouths without gradient estimates because the original elevation

We considered *exposure*, or the assets that could be adversely affected by structure damage (IPCC, 2014), as represented with by the intersection of built-up areas (BAU) (Built-up Areas Boundaries; <https://data.gov.uk/dataset/15e3be7f-66ed-416c-b0f2-241e87668642/built-up-areas-december-2011-boundaries-v2>, last accessed 01 April 2021) and special areas of conservation (SAC) (Special Areas of Conservation; <https://jncc.gov.uk/our-work/special-areas-of-conservation-overview/>, last accessed 01 April 2021) designated for river-obligate species. As discussed by Finley et al., (2015), human populations outside of built-up areas generally face a lack of road-network redundancies or alternative routes, and so frequent structure damage can disconnect communities by disrupting traffic-flow, emergency management, production, logistics, and business (Pregolato 2019). Special areas of conservation designated for river-obligate species were included in exposure (Table S1 in Supplement), because the life cycles and persistence of these fishes and mussels depend on aquatic habitat connectivity, which can be disrupted by poorly constructed and damaged structures (see Sleight and Neeson, 2018; Gillespie et al., 2014). We categorised all culverts and bridges as either inside or outside built-up areas or special areas of conservation, where those that were outside built-up areas and inside special areas of conservation had high exposure (Fig. 1).

(NRW) (Flooding likelihood; <https://datamap.gov.wales/layergroups/inspire-nrw:FloodRiskAssessmentWales>, last accessed 30 December 2021). Annual flooding likelihood was modelled by NRW for both rivers and small watercourses (see [Natural Resources Wales, 2019](#)) and categorised as high (>3.3% likelihood/year), medium (1.0–3.3% likelihood/year), and low (0.1–1.0% likelihood/year). We determined hazard of flooding at each high vulnerability culvert and bridge as the category (high, medium, or low) occupying most of the area within a 100m buffer around each structure. We considered risk, or the potential for impacts on nature and people from structures under flooding, as the intersection of vulnerability and hazard, to identify high-risk culverts and bridges (Fig. 1).

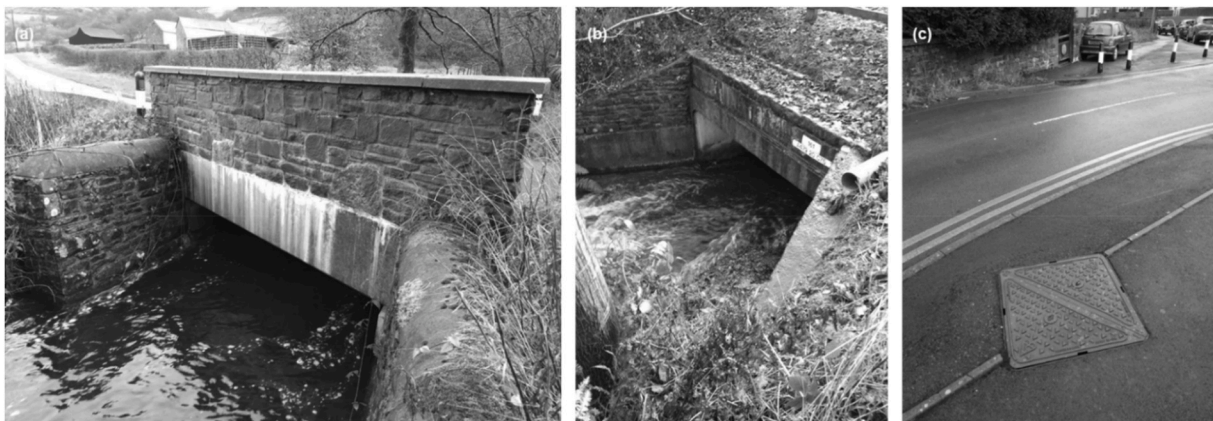
Fig. 4. Examples of culverts on small rivers with high gradients that either showed little to no evidence of physical degradation or could not be visually assessed in River Usk catchment, United Kingdom. The culverts in (a) and (b) were visually assessed and showed little to no evidence of physical degradation but had obvious streambank erosion and scouring at the structure. The culvert in (c) could not be visually assessed because it was under a human settlement.

More than 40% of all high-risk structures occurred in River Usk catchment, and we set-out to visit roughly 10% ($n = 35$) of those in our on-ground visual assessment. The majority (83%; 29/35) of the structures were correctly attributed (27 culverts and 2 bridges) and 3% (1/35) were attributed as a culvert when a bridge. A further 14% (5/35) of structures were located on private land and inaccessible for our visual assessment of sensitivity. Of the structures ($n = 30$) we assessed for sensitivity, 53% ($n = 16$) had obvious physical degradation, streambank erosion, and scouring (e.g., Fig. 3c and d), 17% ($n = 5$) showed little to no evidence of physical degradation but had obvious streambank erosion and scouring (Fig. 4a and b); and the remaining 30% ($n = 9$) could not be visually assessed because they were below human settlements (Fig. 4c).
